CALAVERAS PUBLIC UTILITY DISTRICT

2024 WATER MASTER PLAN UPDATE

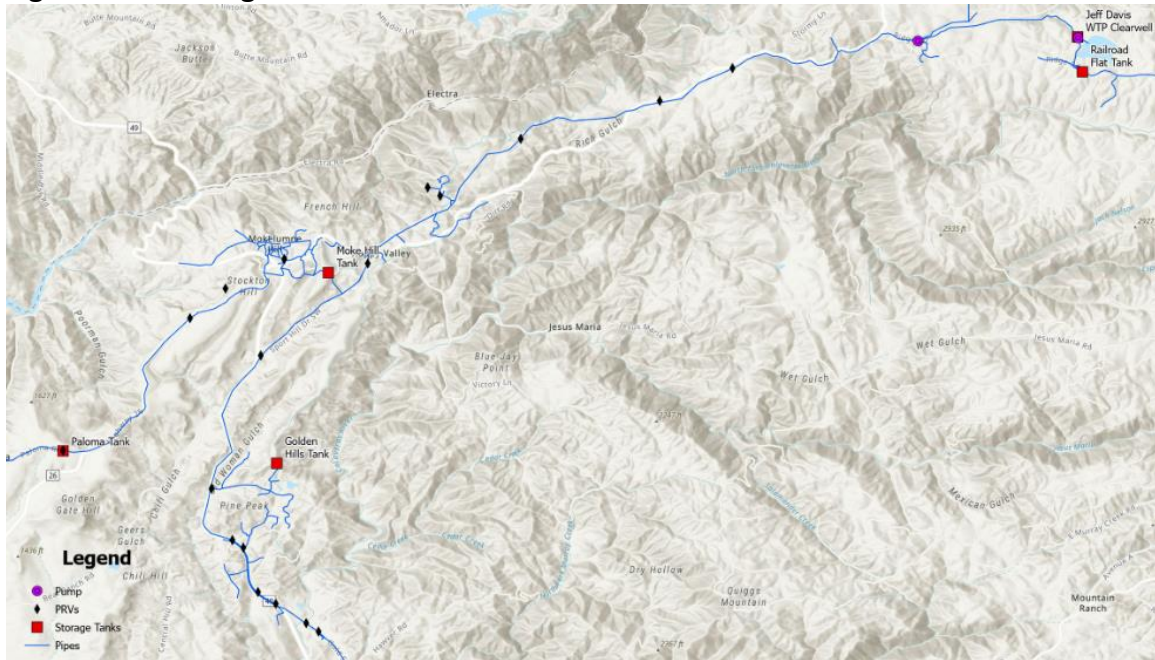
2.2.1 Jeff Davis Water Treatment Plant

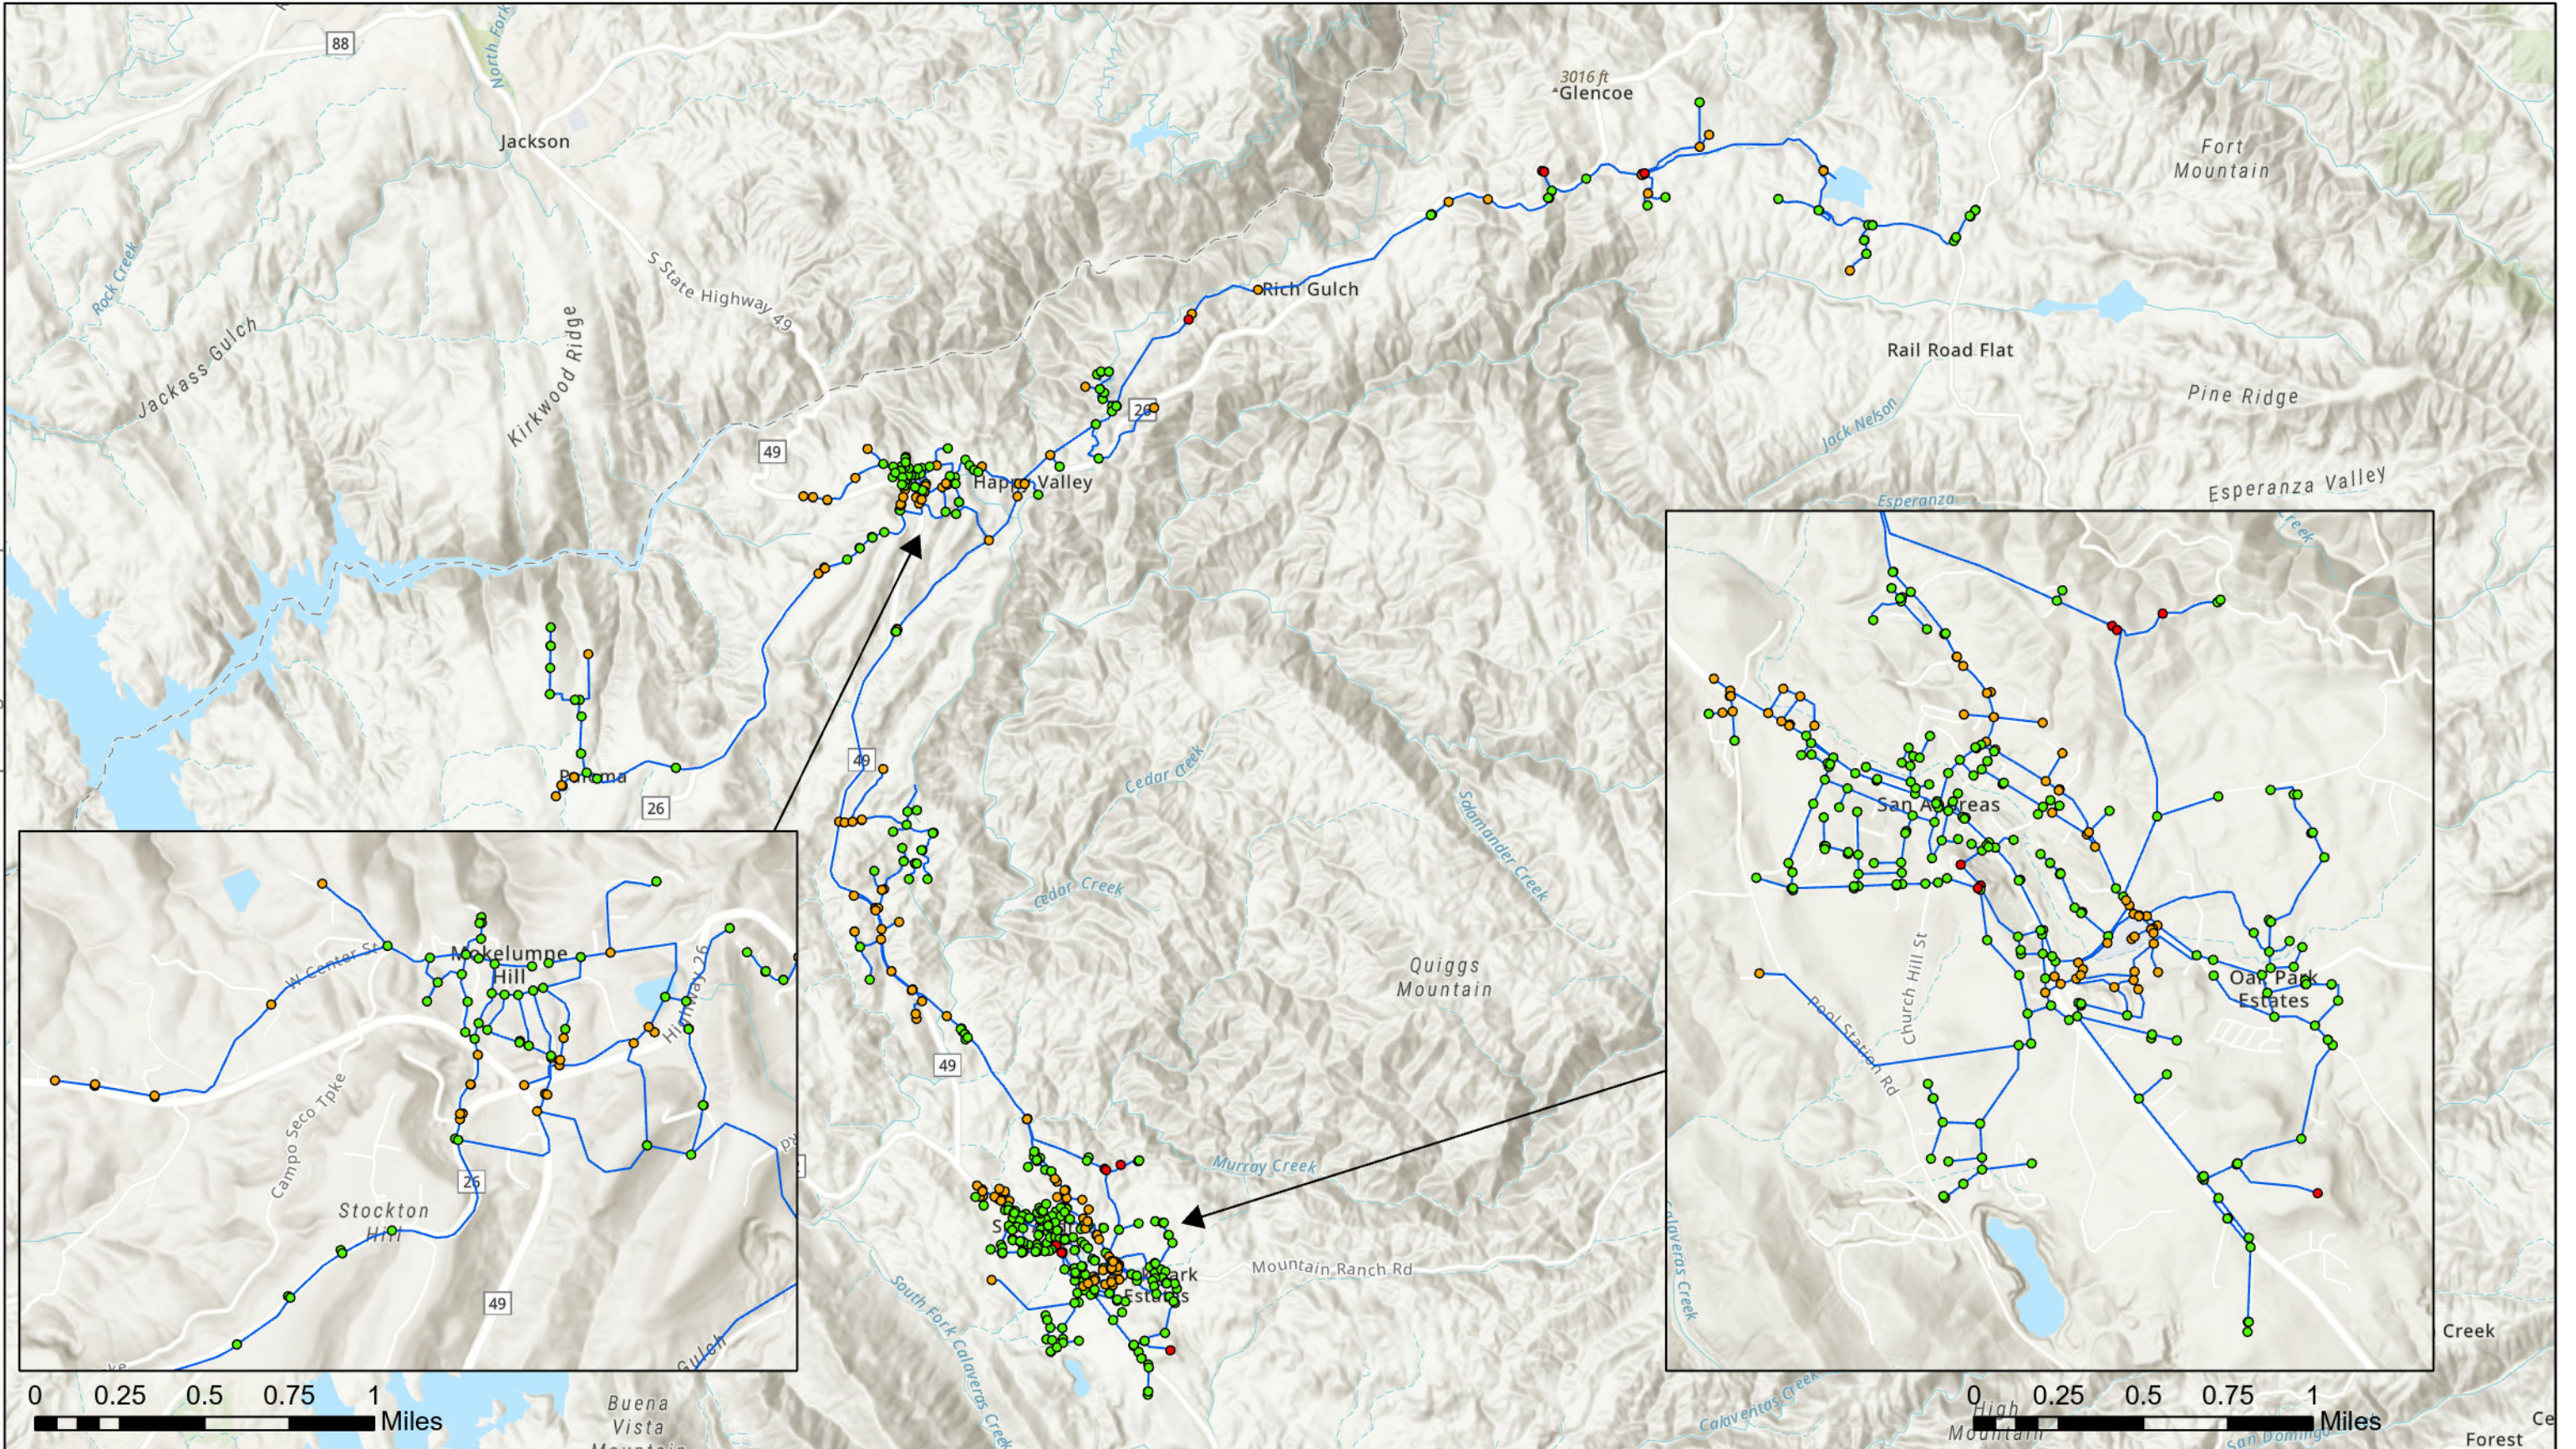
PBI ENGINEERING CONSULTING™
 80 Blue Ravine Rd., Suite 280
 Folsom, CA 95630
 Phone: (916) 608-2212

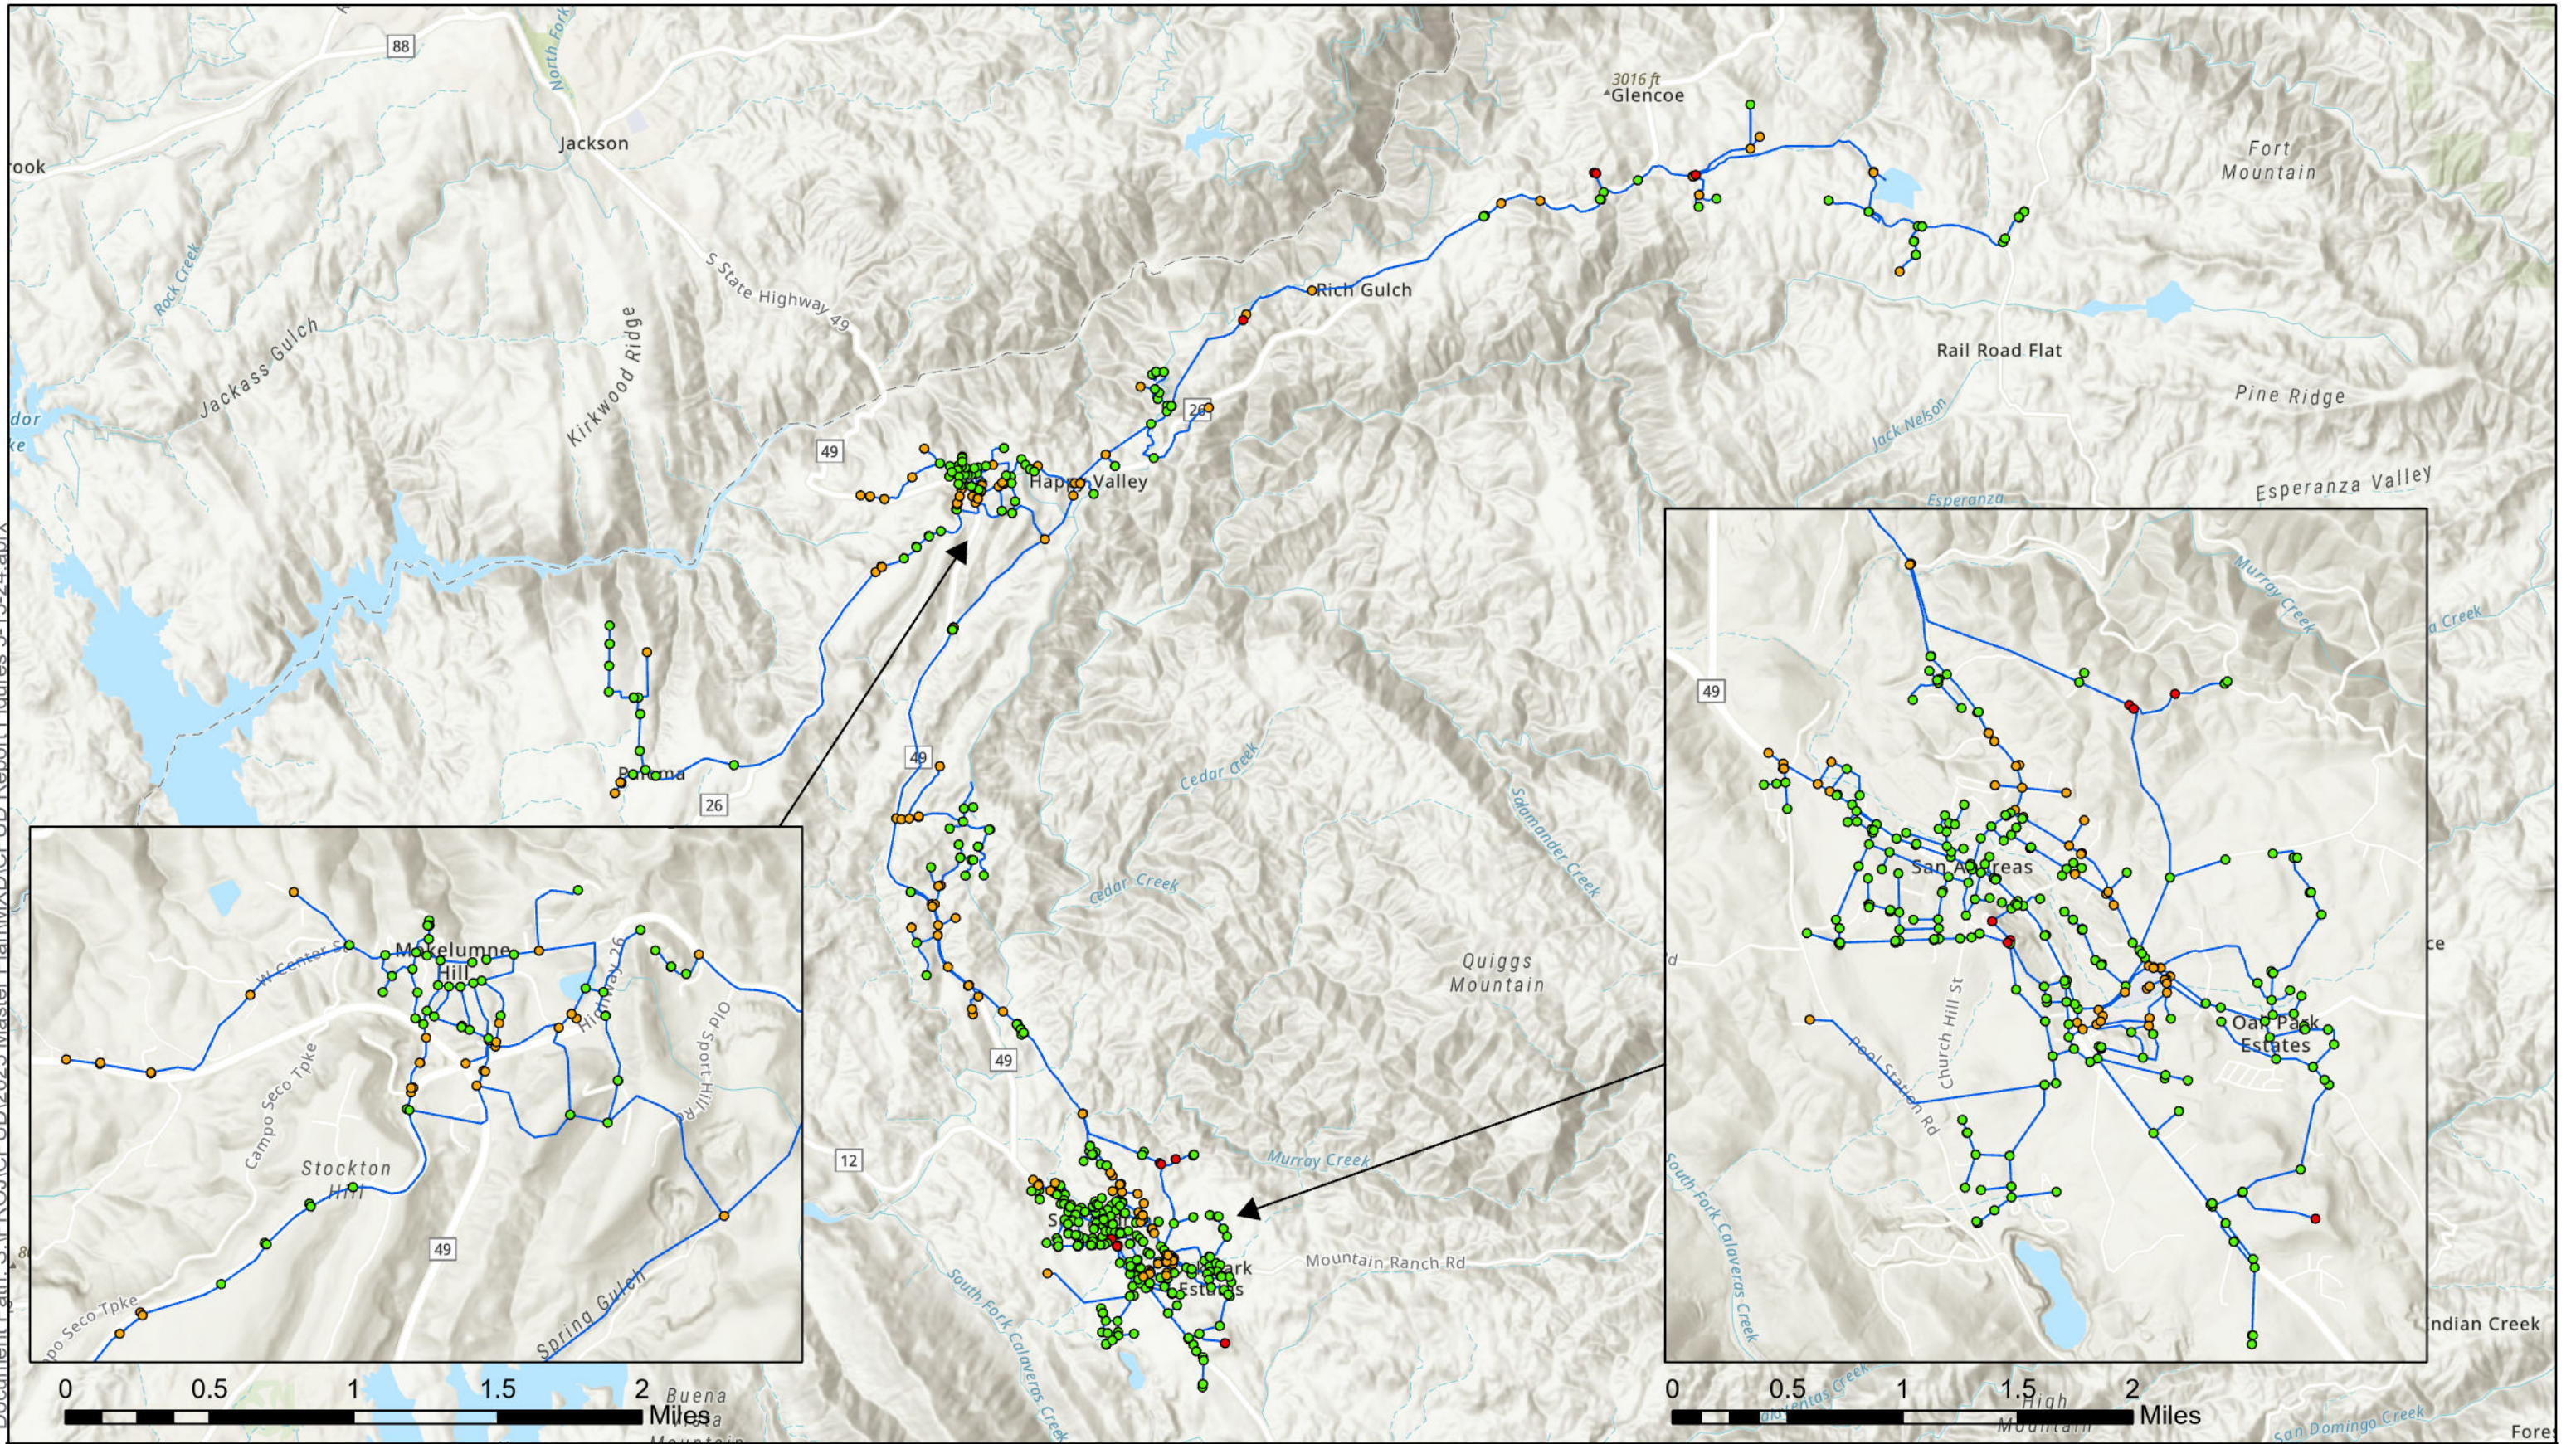
PBI ENGINEERING CONSULTING™
 80 Blue Ravine Rd., Suite 280
 Folsom, CA 95630
 Phone: (916) 608-2212

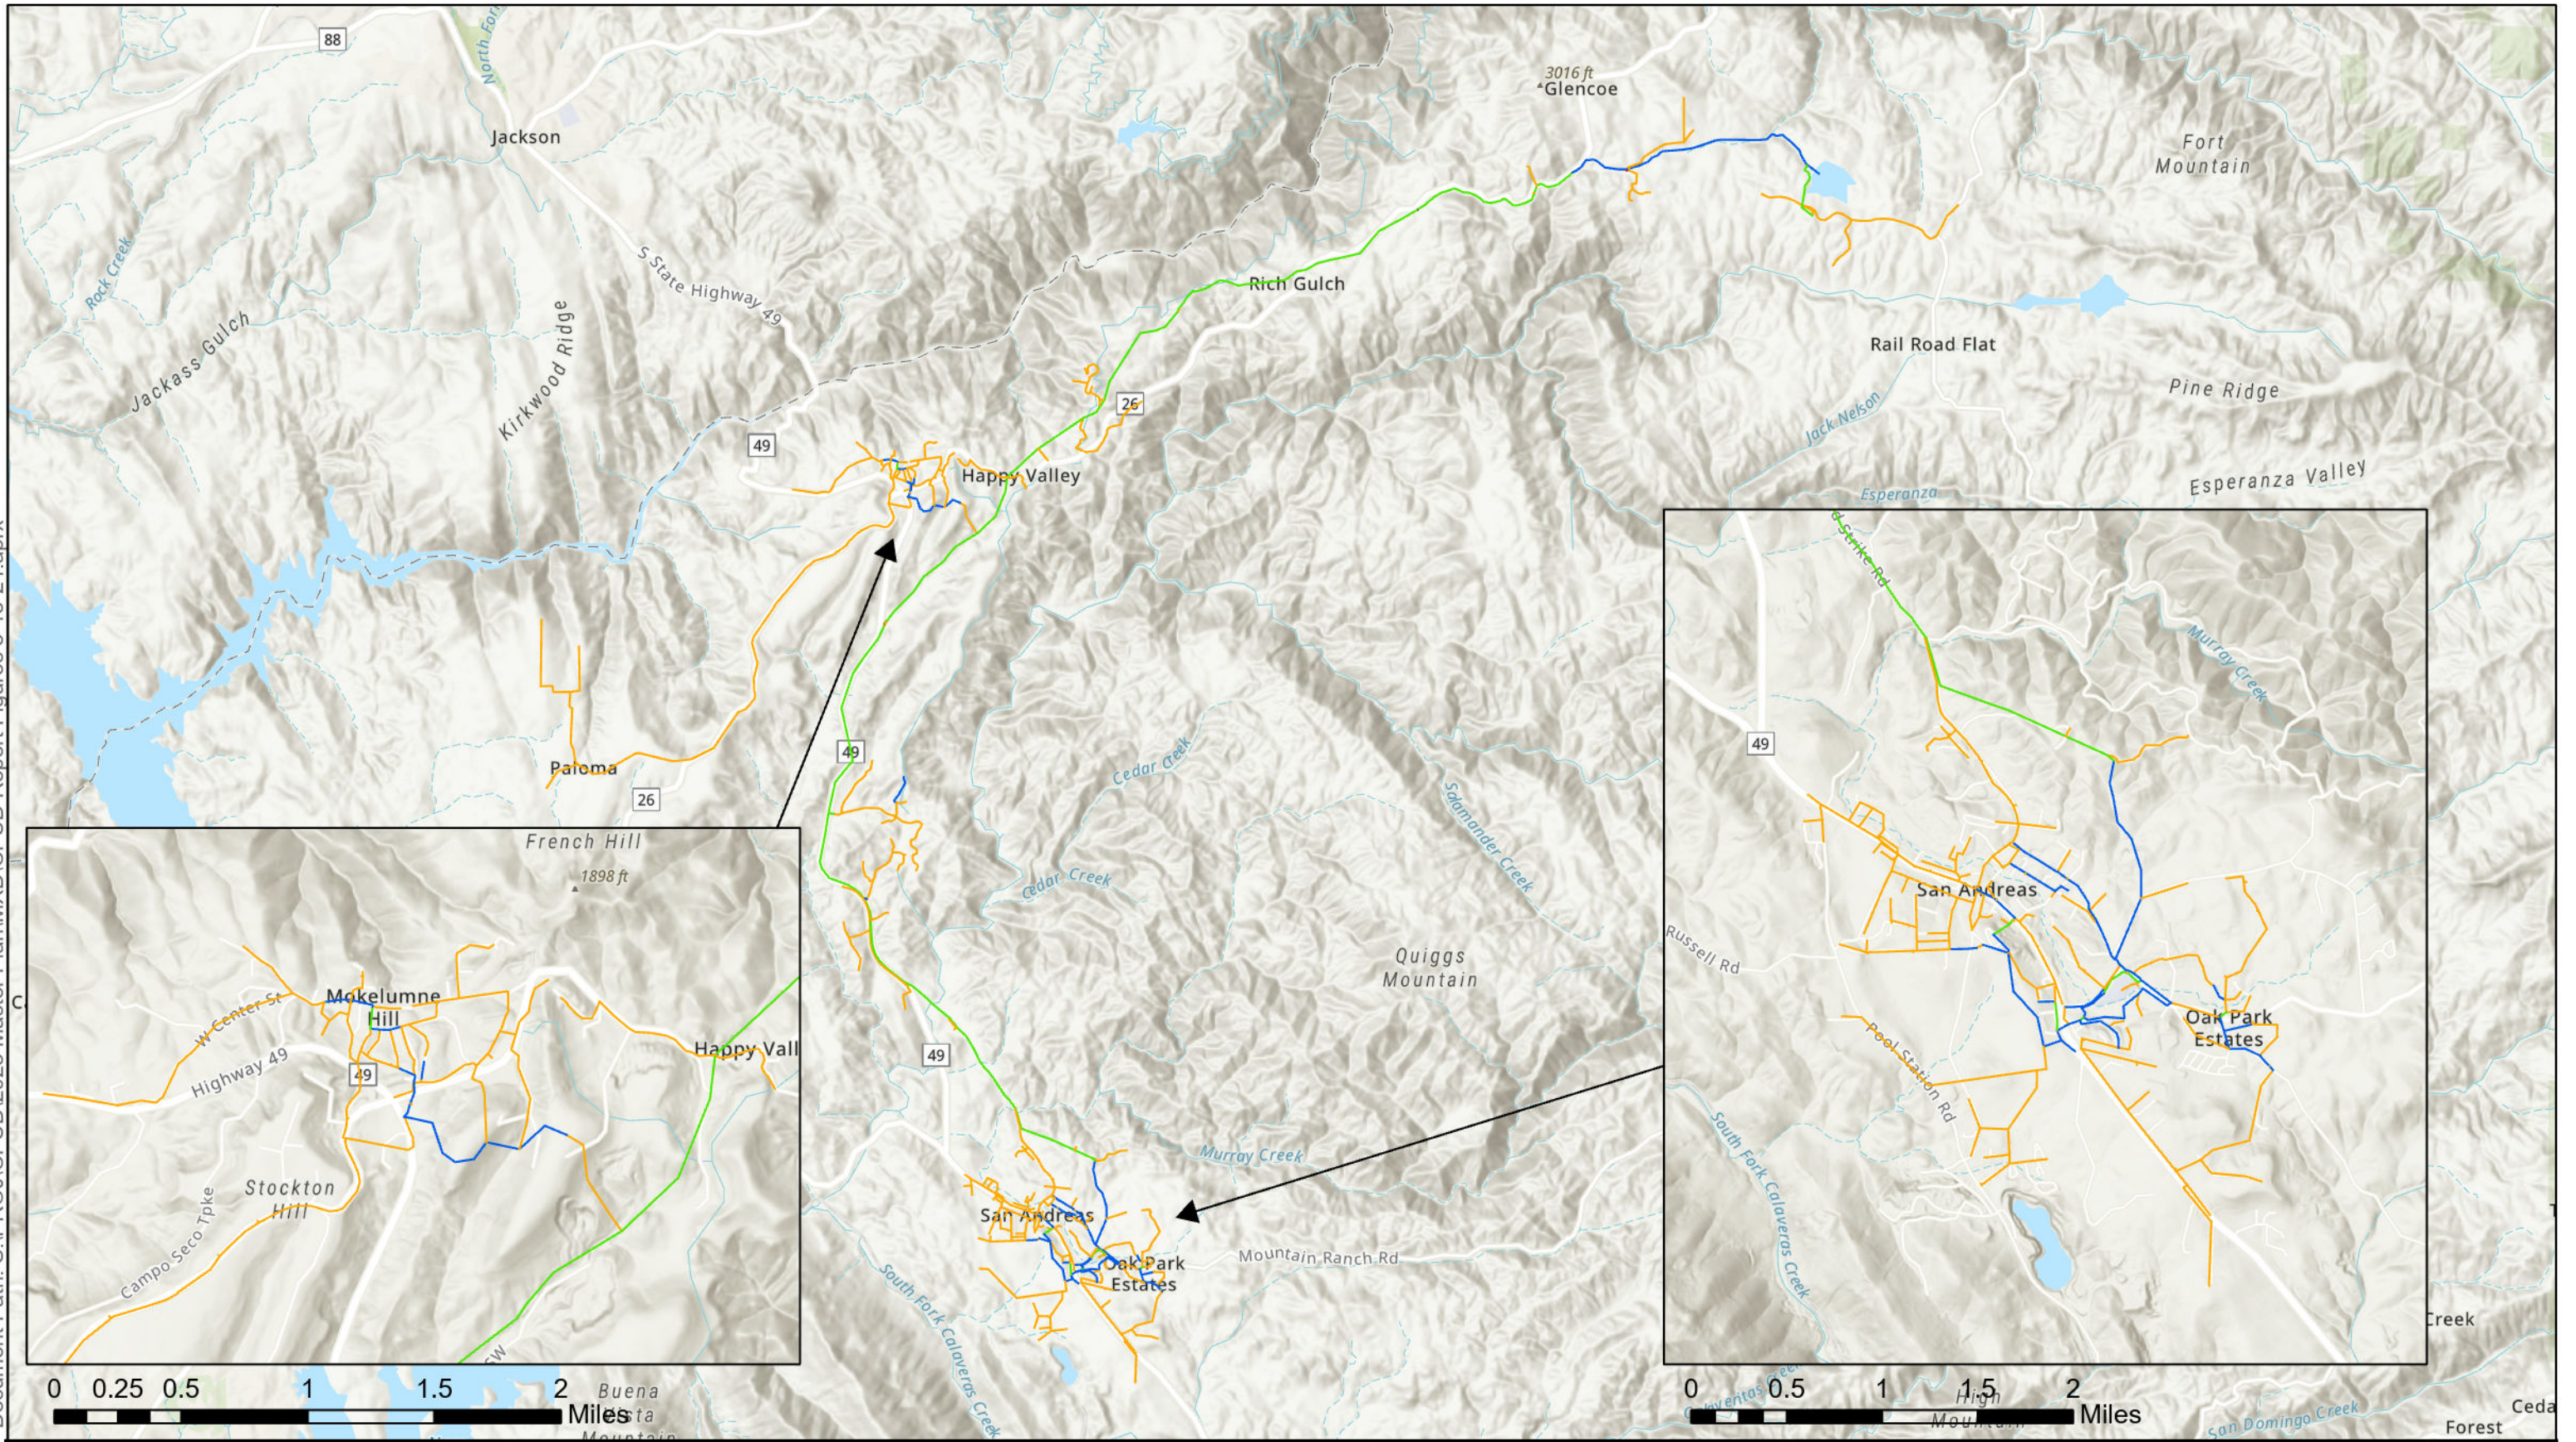
With the exception of the transmission mains, a vast majority of the distribution pipelines have velocities less than 2.5 ft/s. Therefore, all distribution pipelines are recommended to be placed on a flushing program by the District to ensure any sediment that settles under low-velocity conditions gets flushed out of the system.

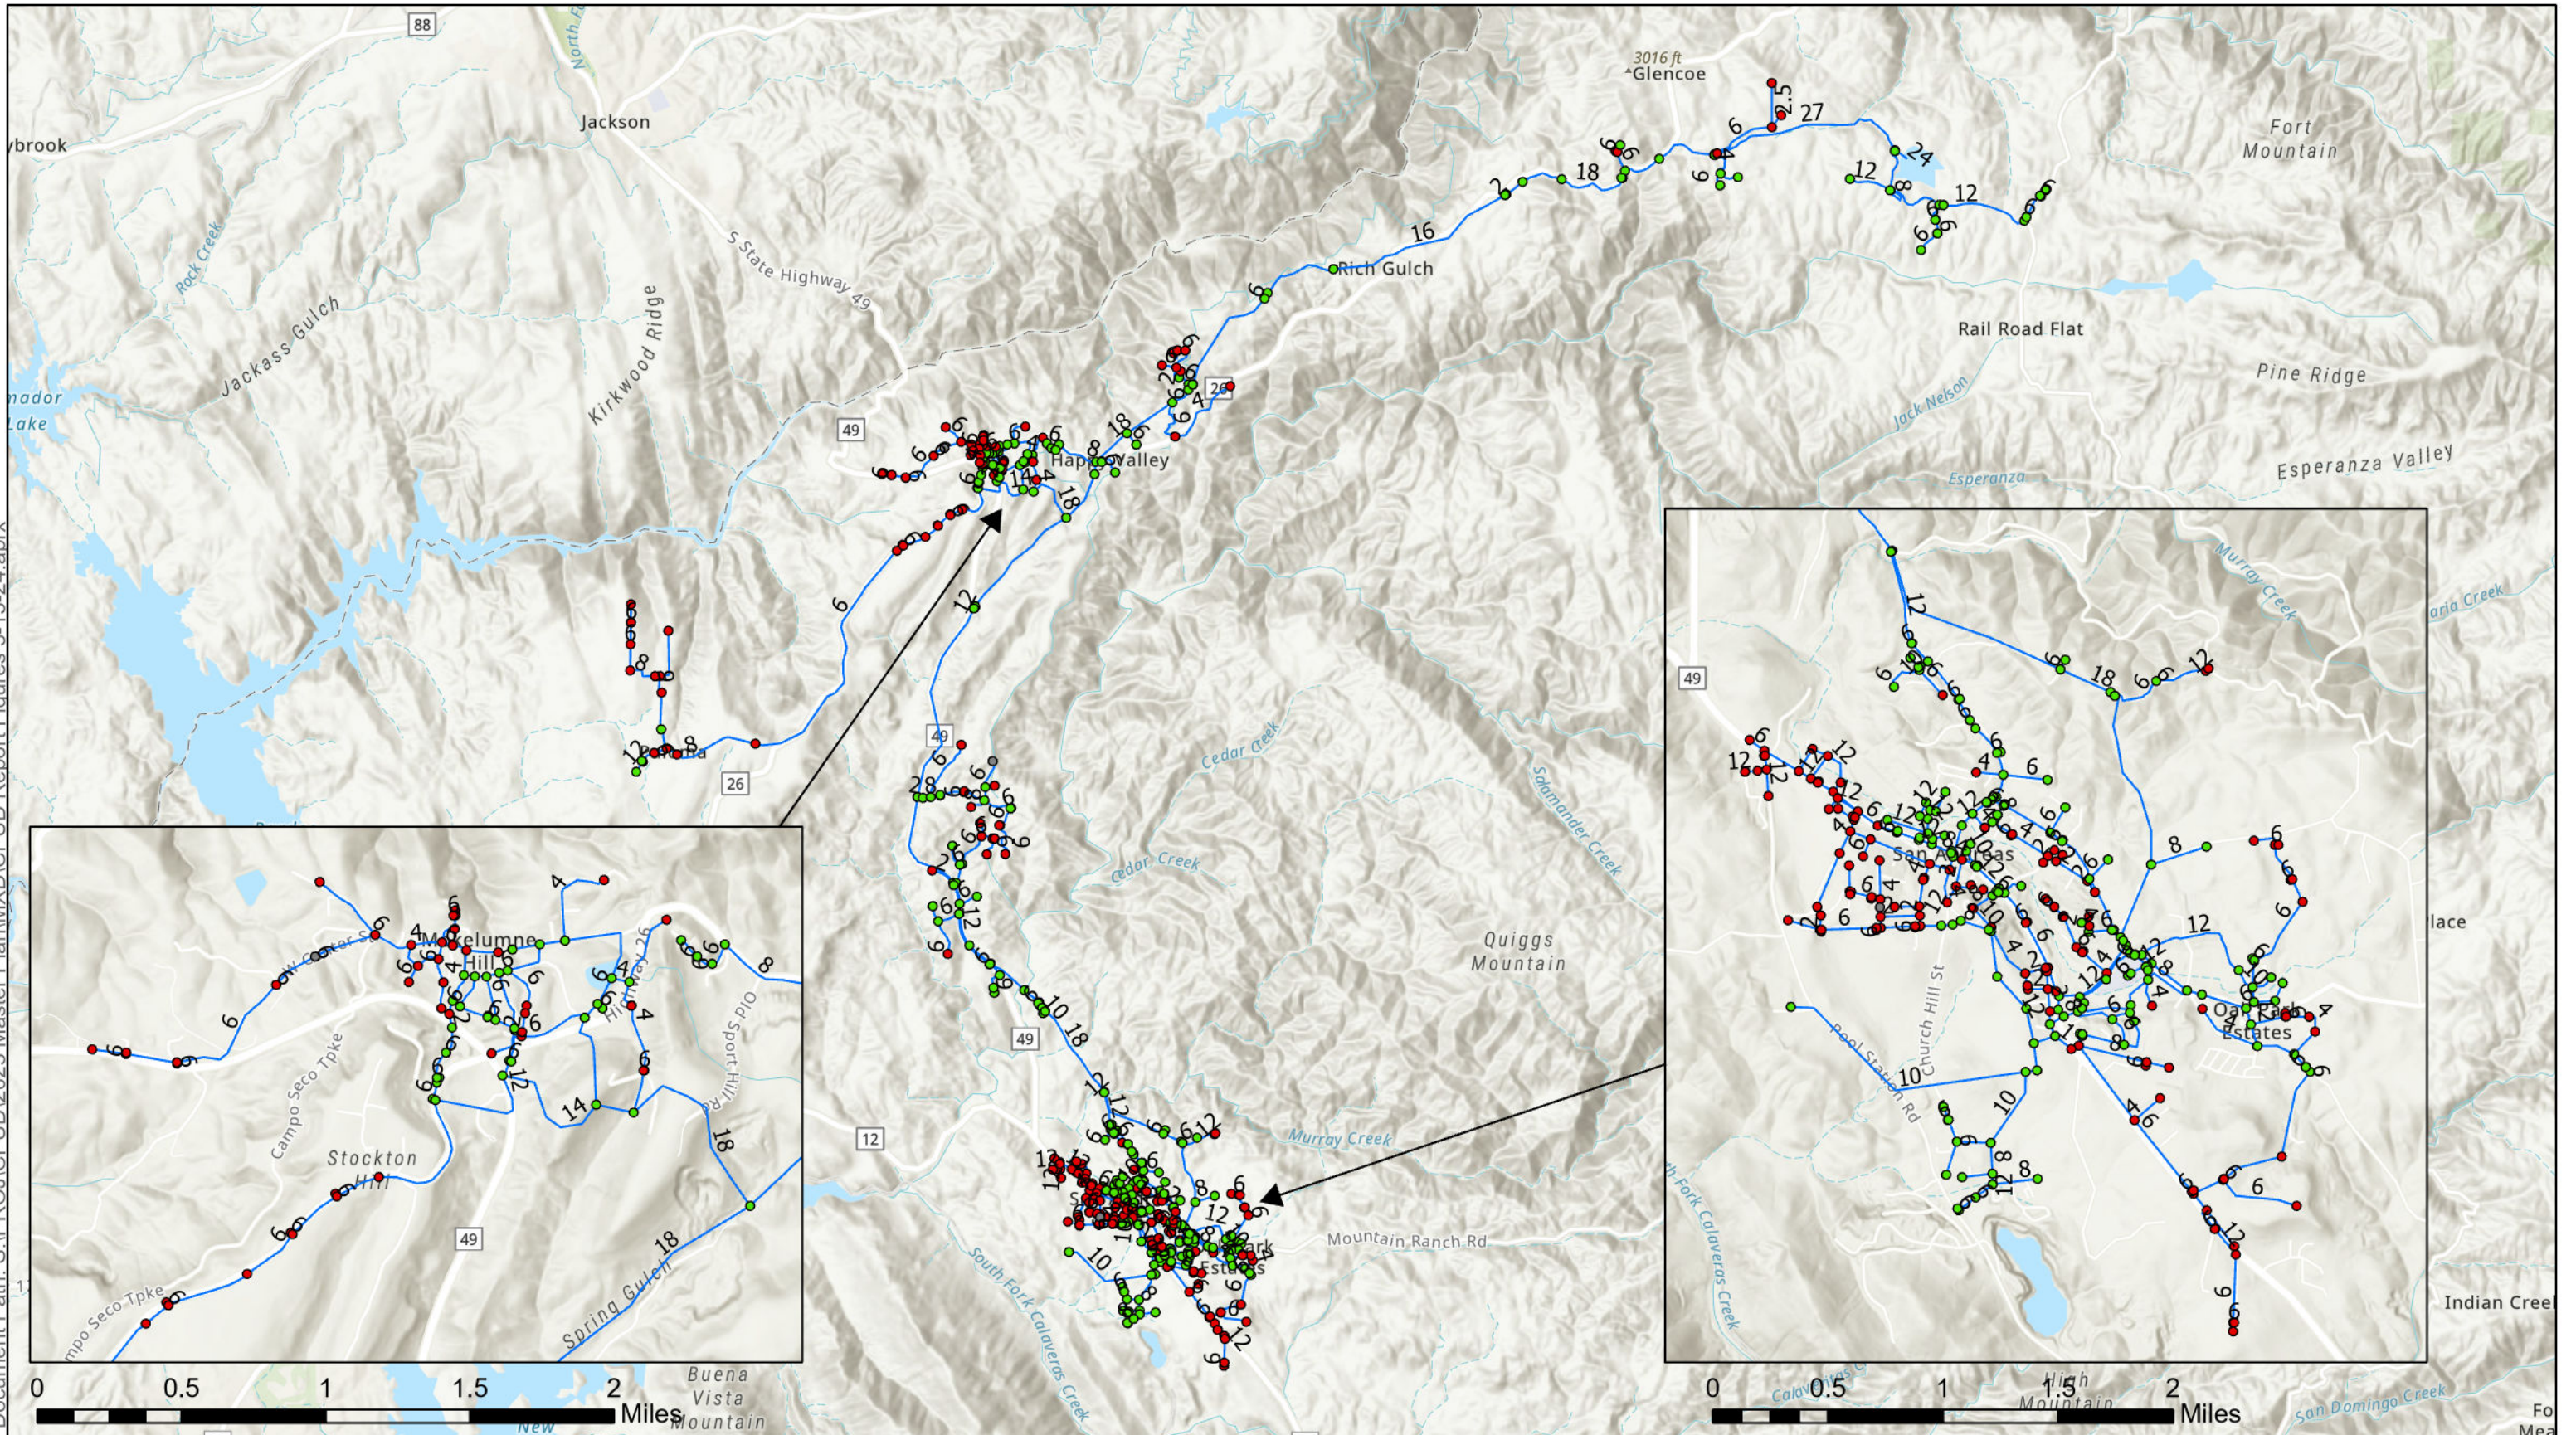
Note that the existing pipelines do not require immediate replacement as the system is otherwise performing adequately. These pipelines can be upsized to provide the required fire flow with the District's pipeline replacement program over time. Appendix B includes a list of all recommended pipeline improvements to address available fire flow. The areas that currently have a majority of undersized 4-inch mains are within the San Andreas and San Andreas West pressure zones. Therefore, it is recommended that these pressure zones be prioritized over other pressure zone for annual pipeline replacement.

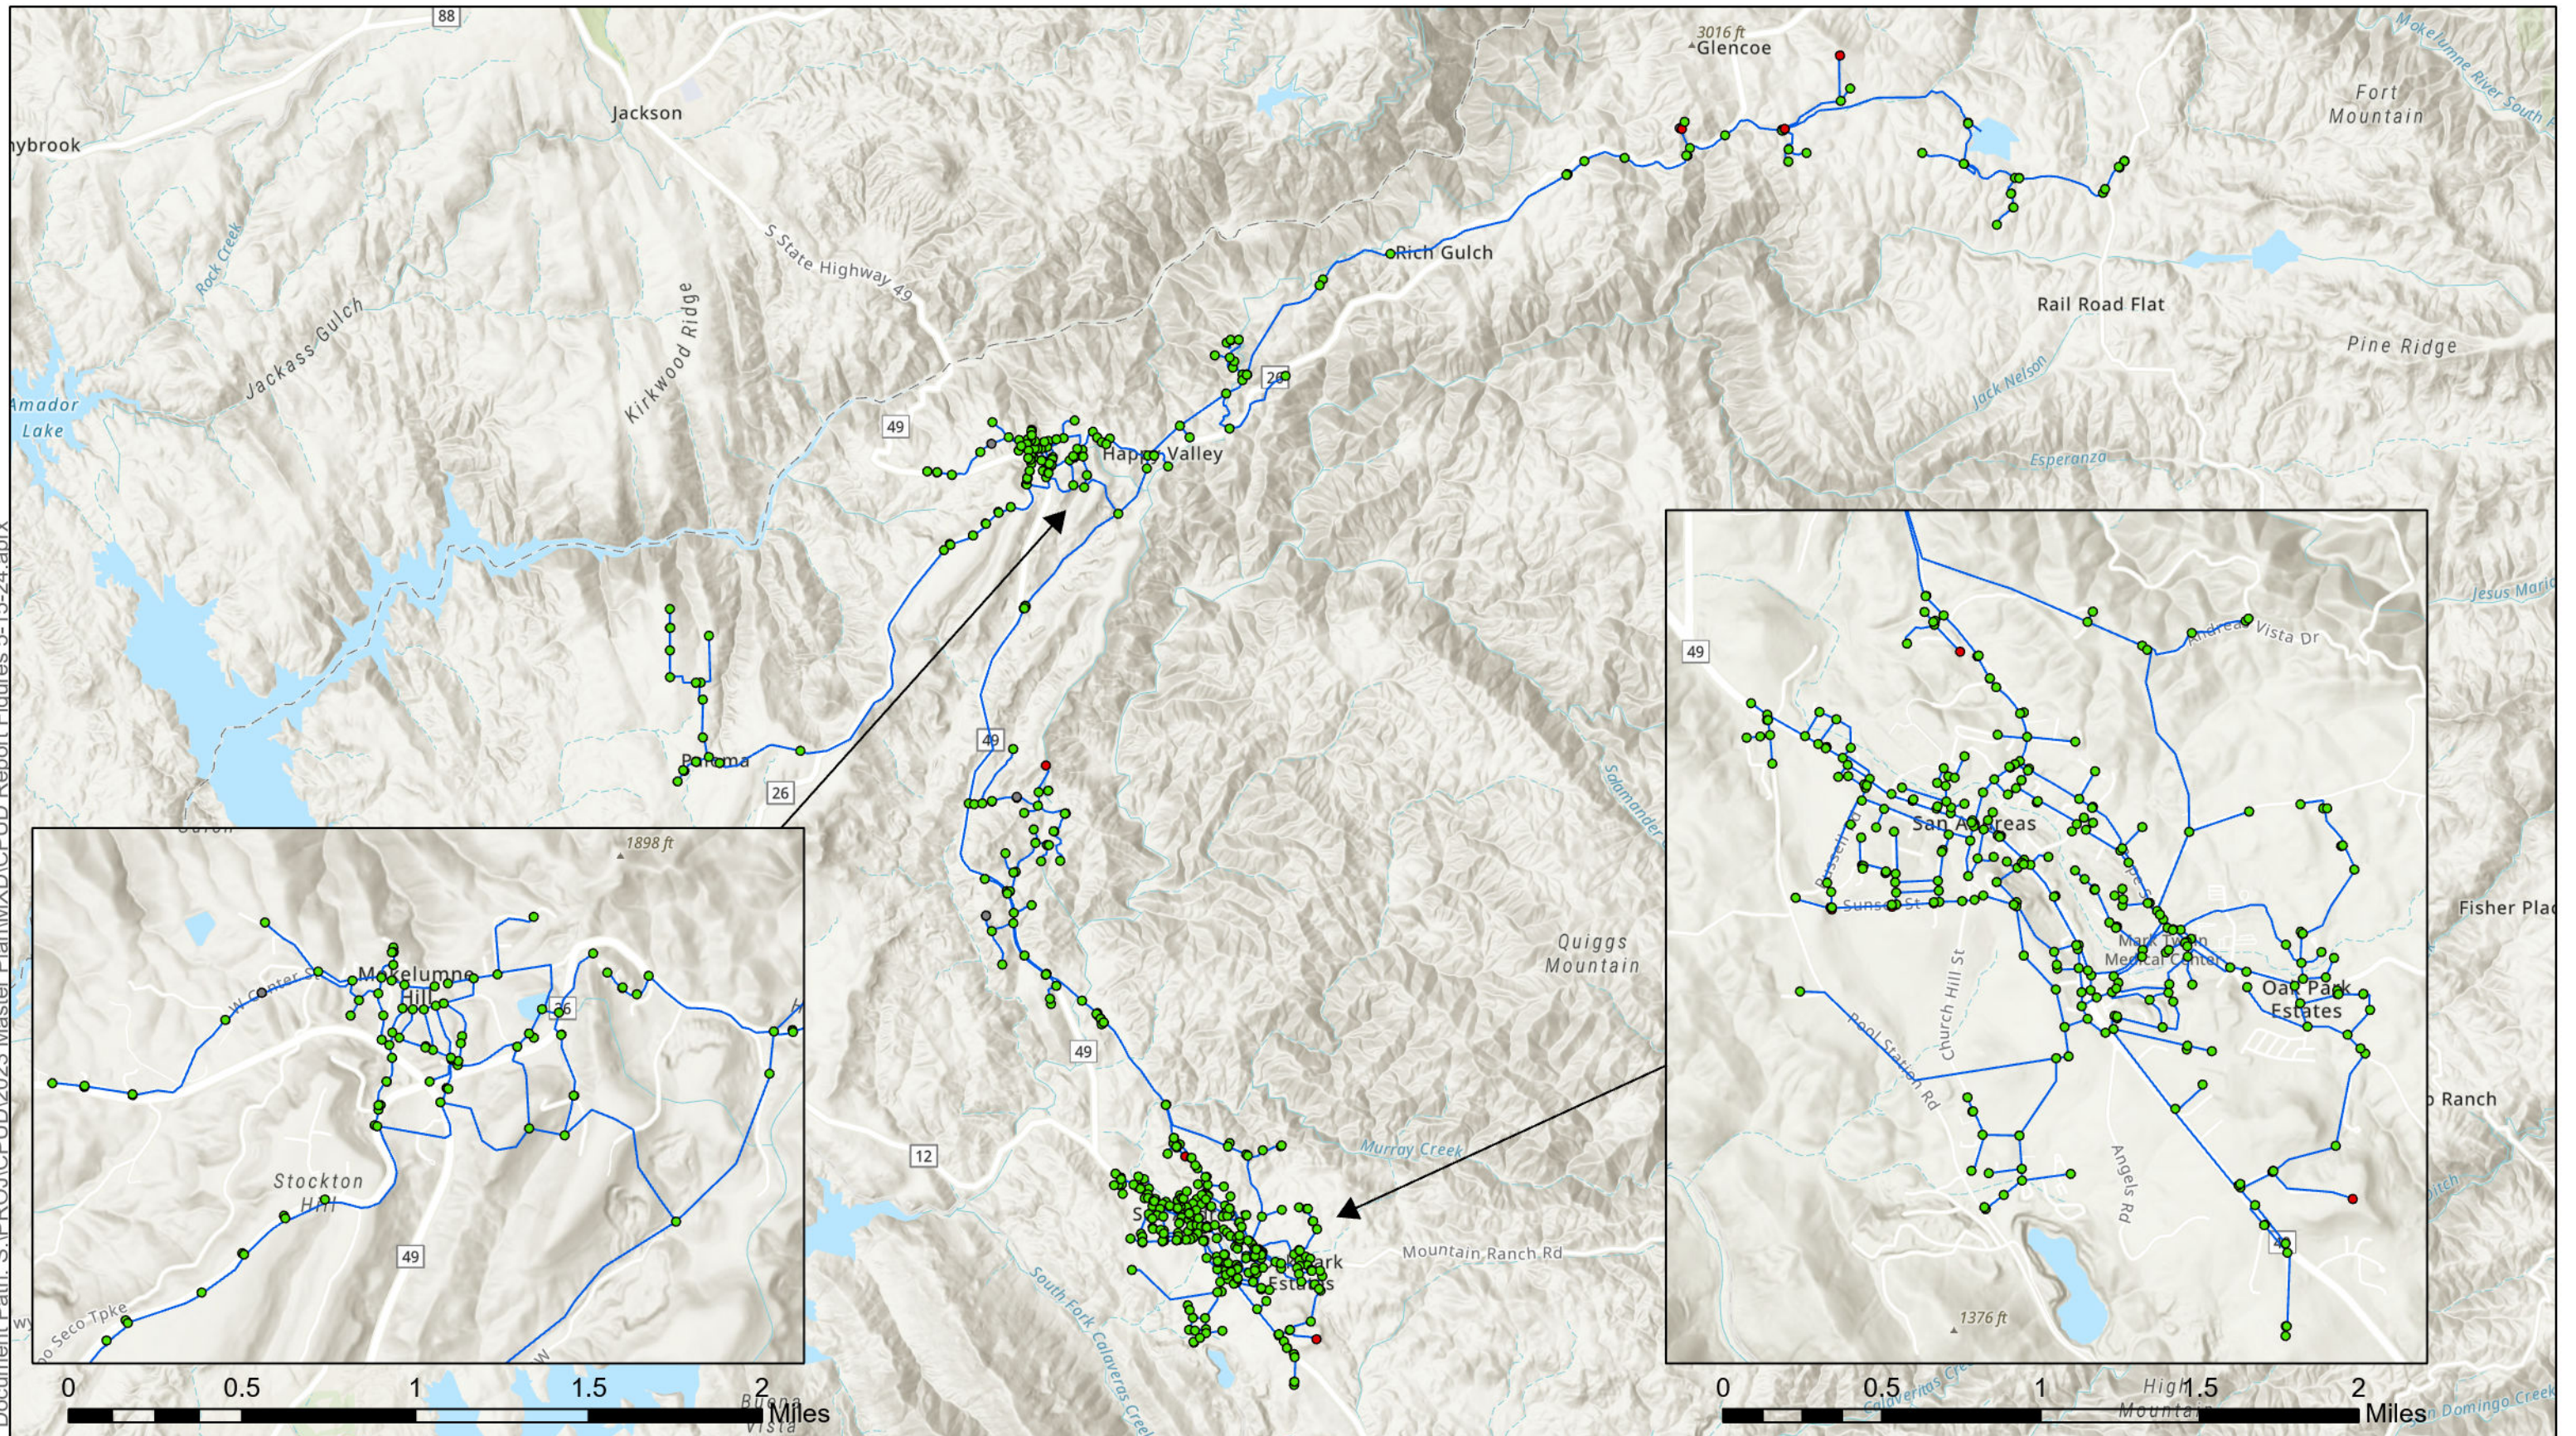
- Legend**
- Compliant
 - Non-compliant
 - Pipe Network

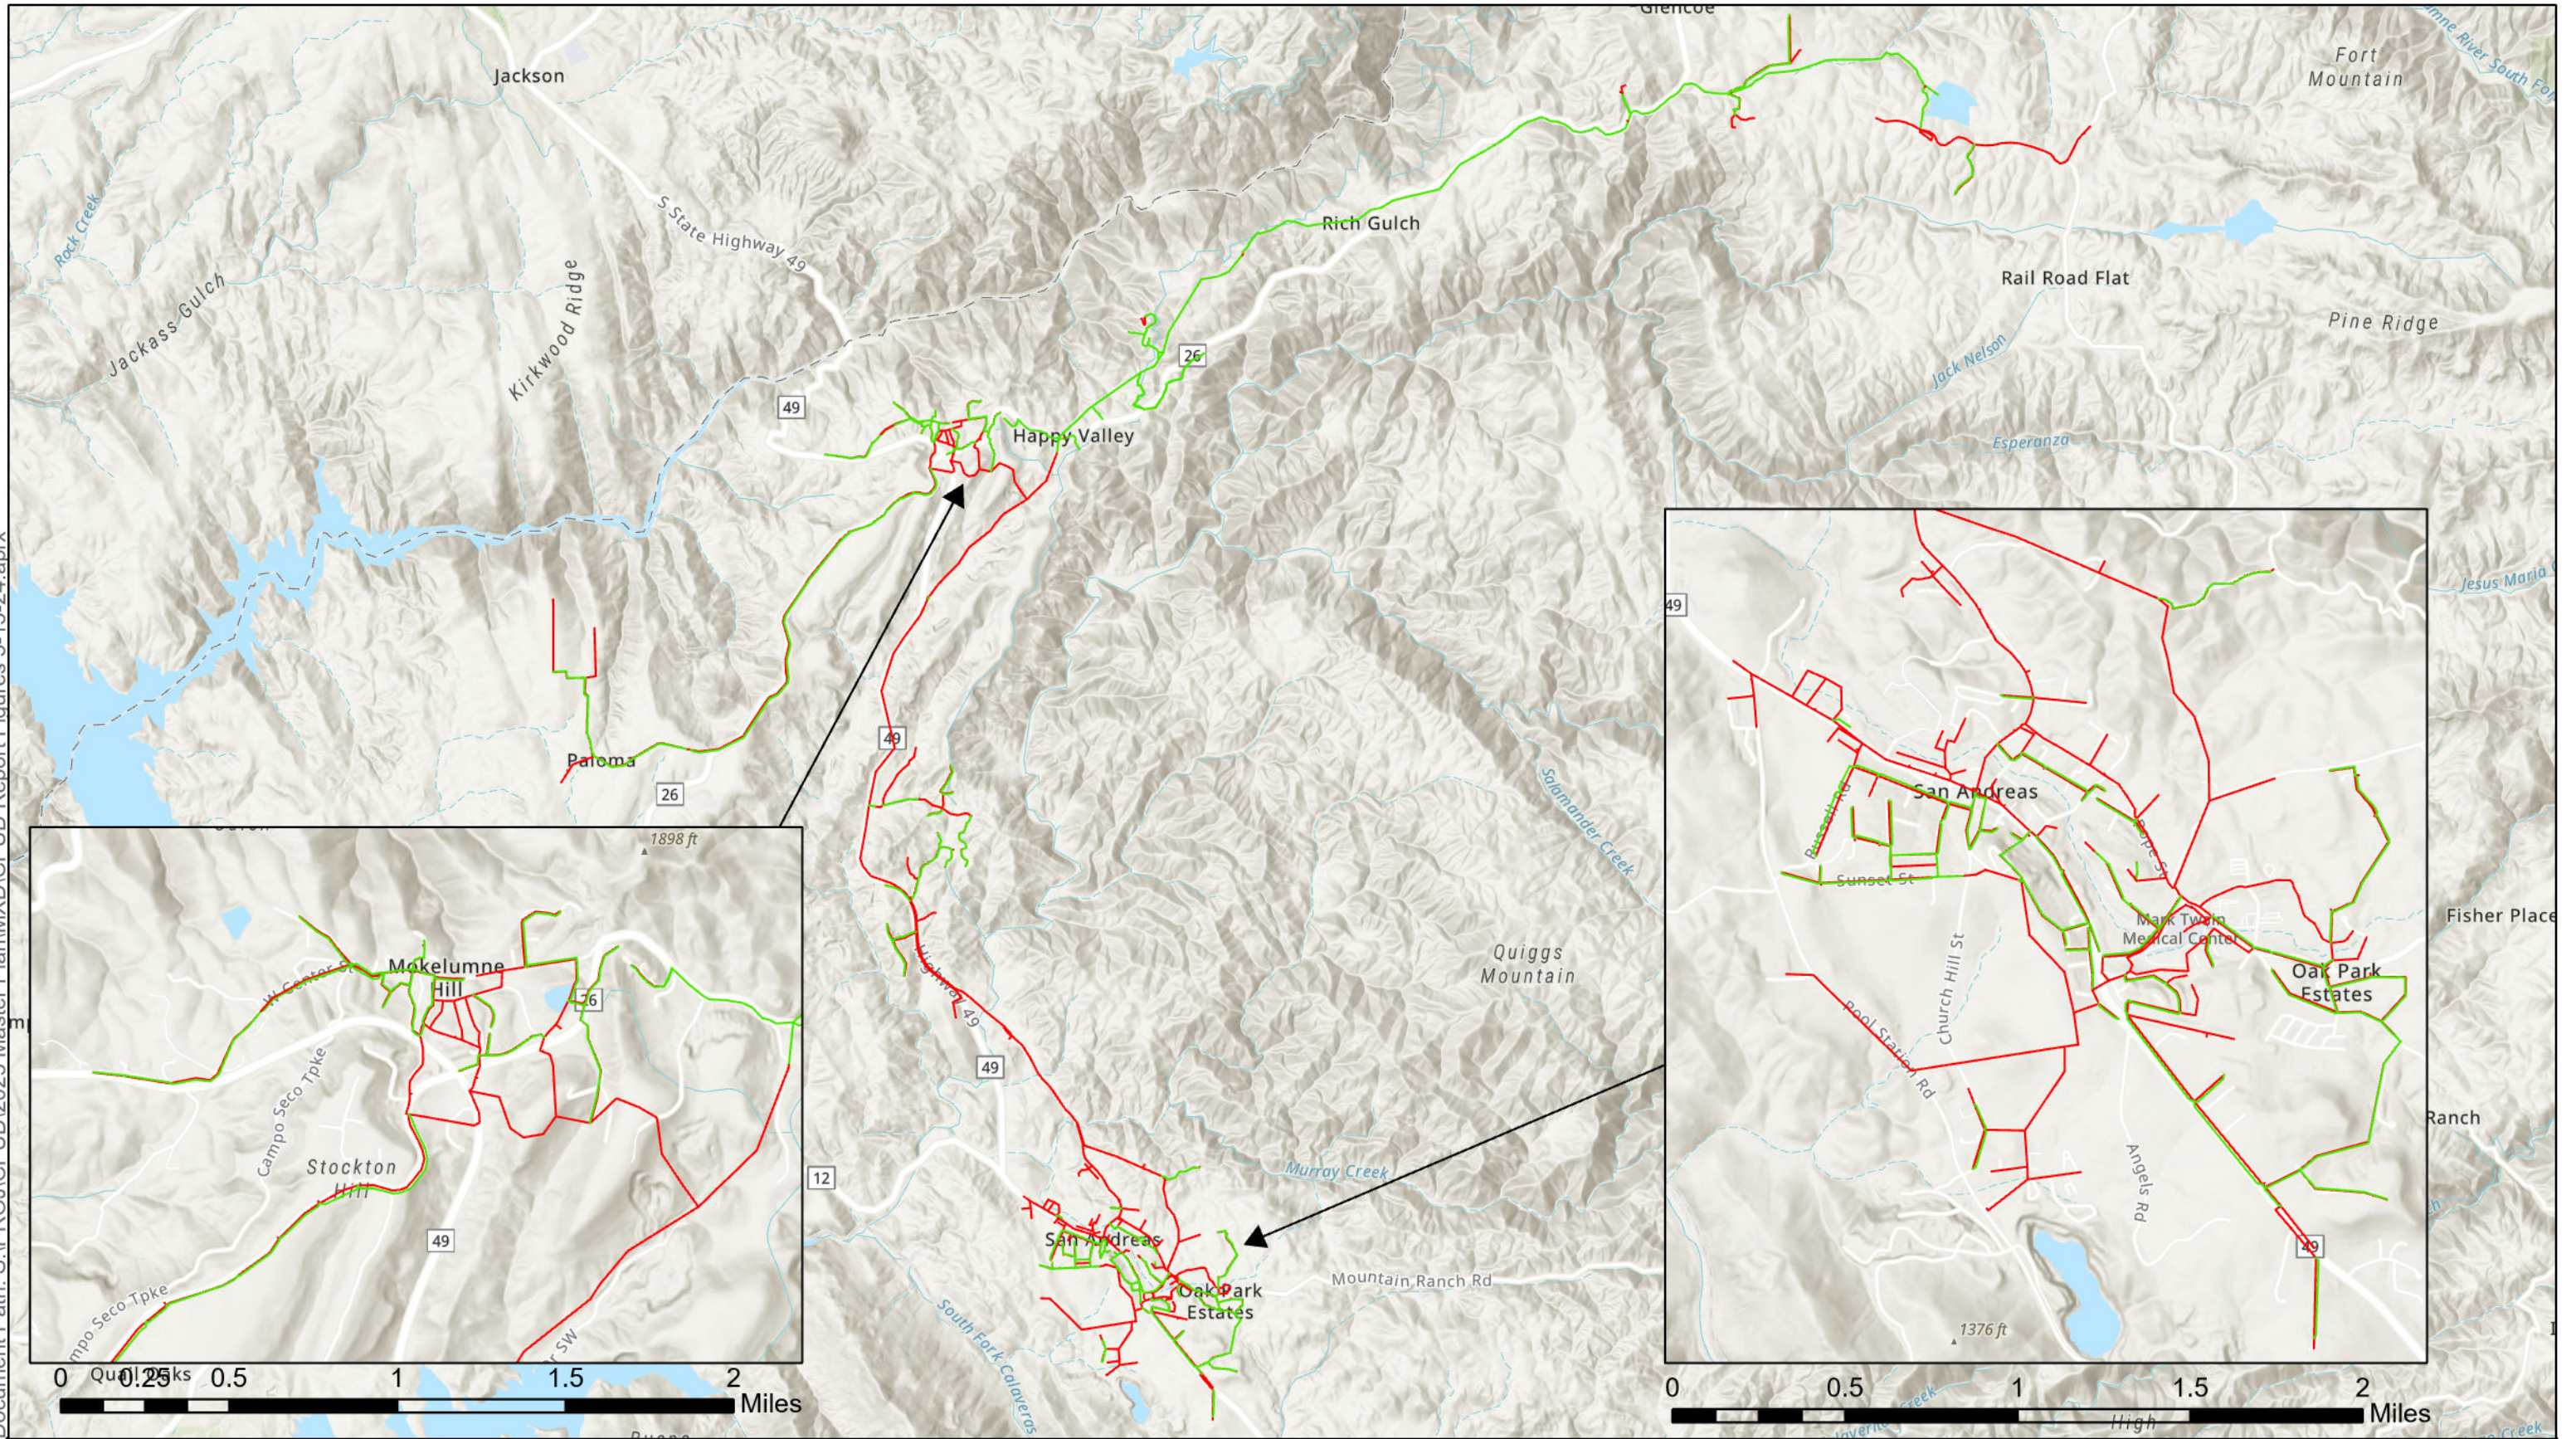
Legend
 — Water Age > 3 Days
 — Water Age < 3 Days
