CALAVERAS PUBLIC UTILITY DISTRICT

2024 WATER MASTER PLAN UPDATE

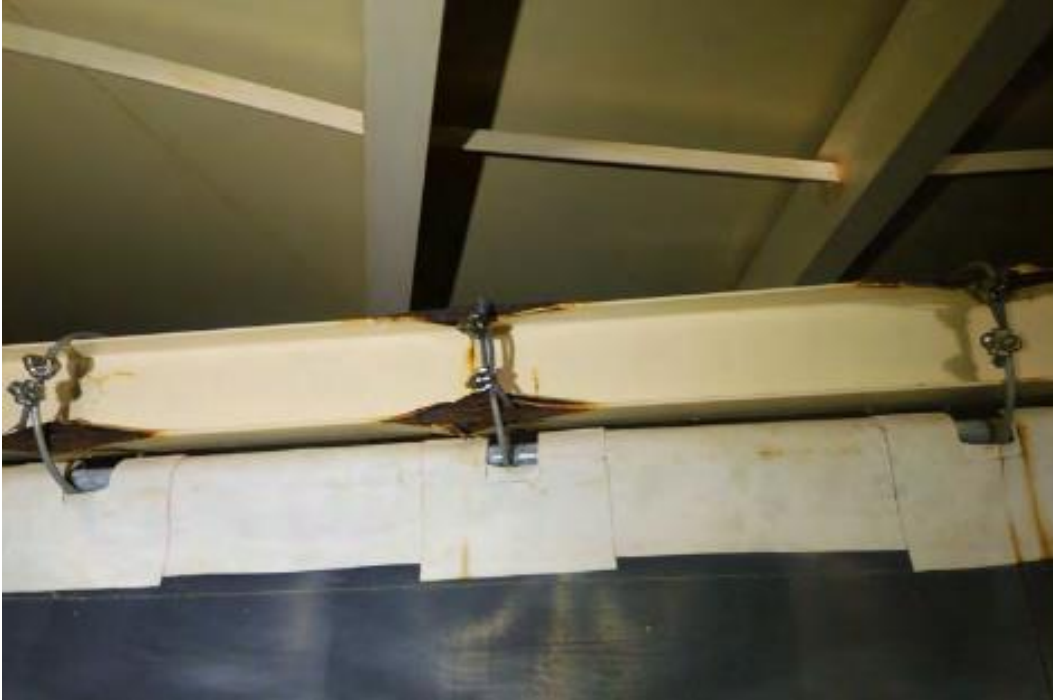
Figure 9-1. Rail Road Flat Tank Dissimilar Metal Location Example

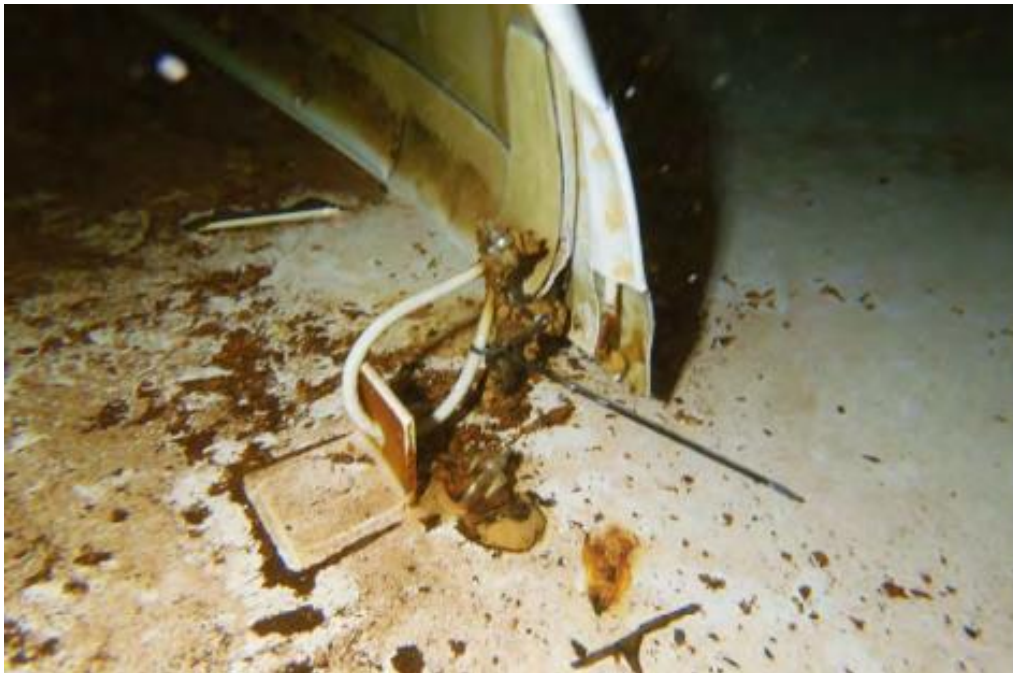
Figure 9-2. Rail Road Flat Tank Interior Floor Example

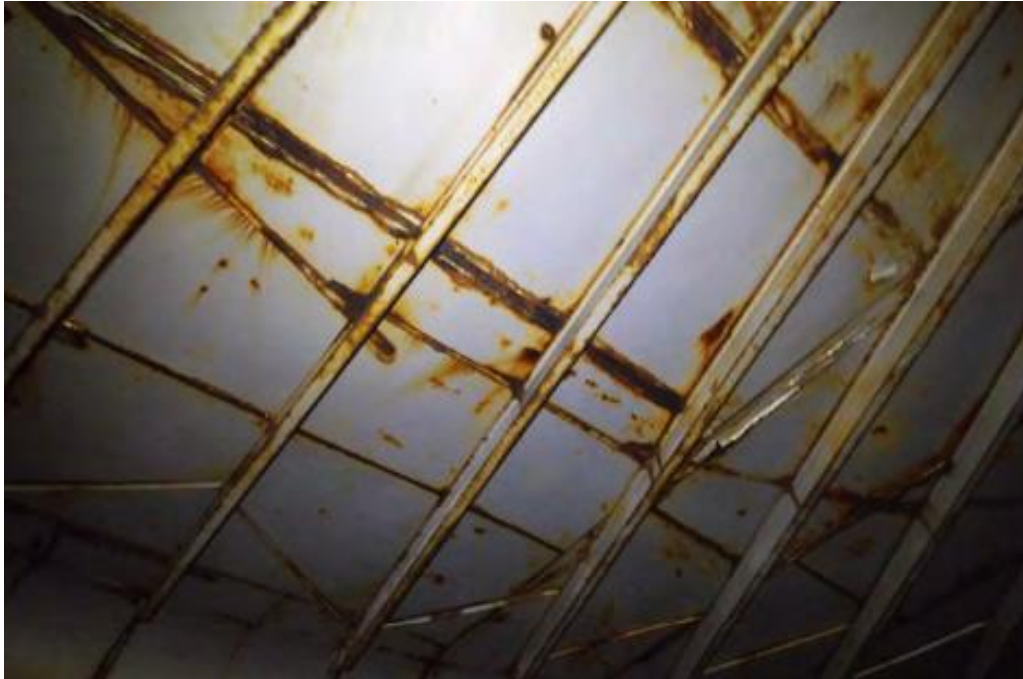
Figure 9-3. Example of Interior Mokelumne Hill Tank Roof

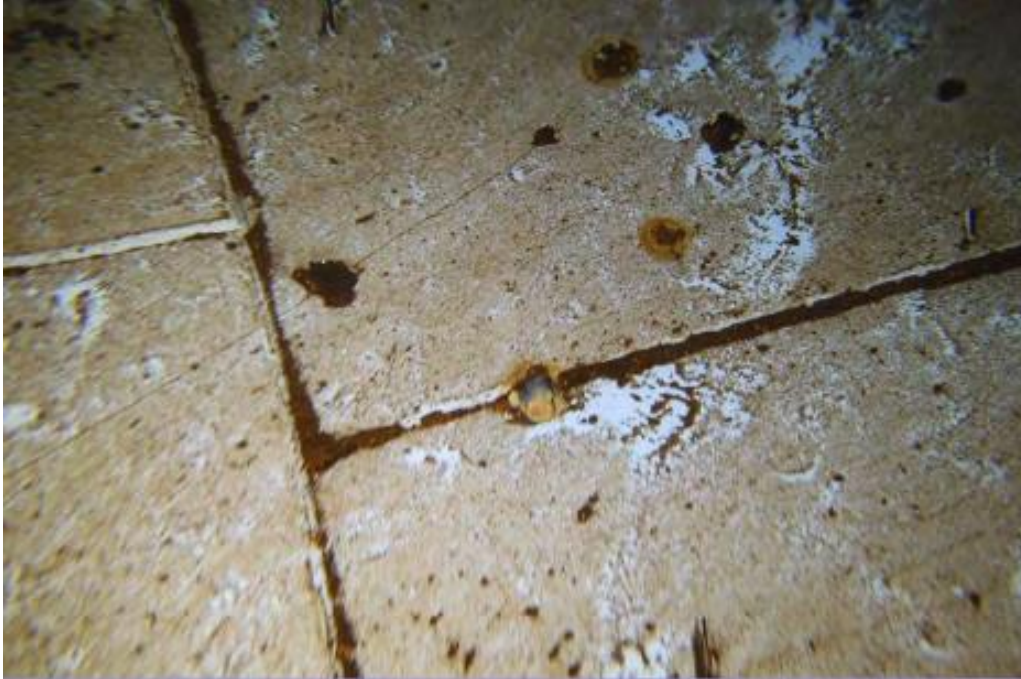
Figure 9-4. Example of Interior Mokelumne Hill Tank Floor

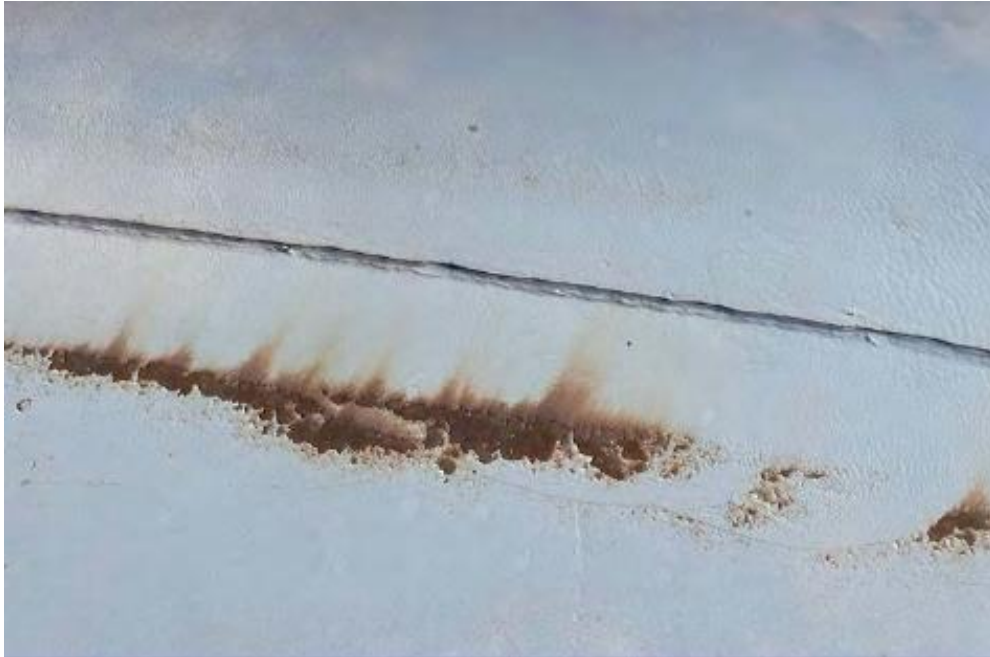
Figure 9-5. Example of Mokelumne Hill Tank Roof

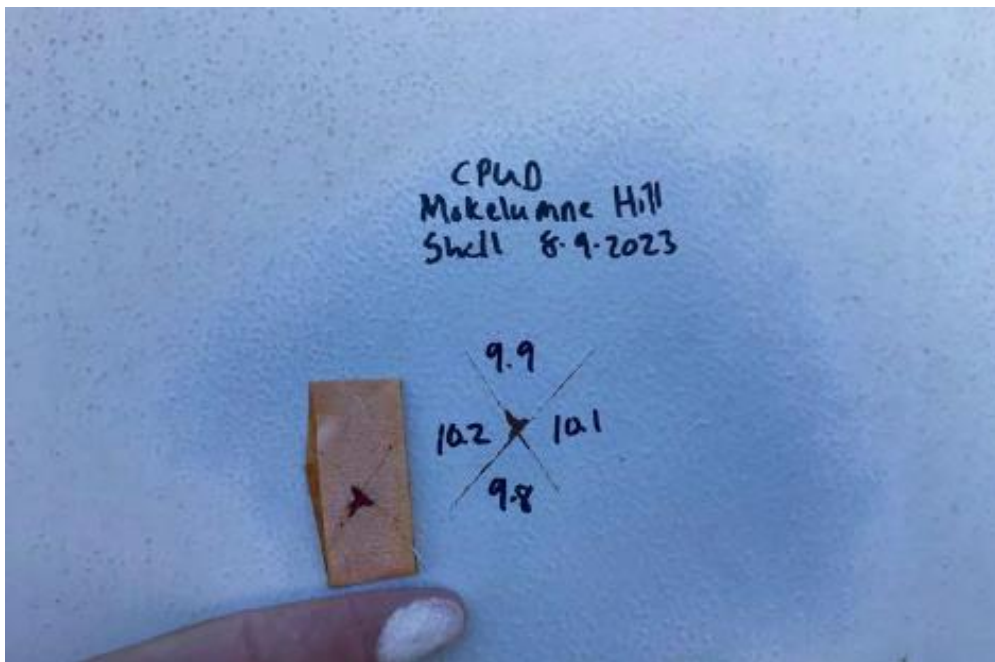
Figure 9-6. Example of Mokelumne Hill Tank Shell Paint

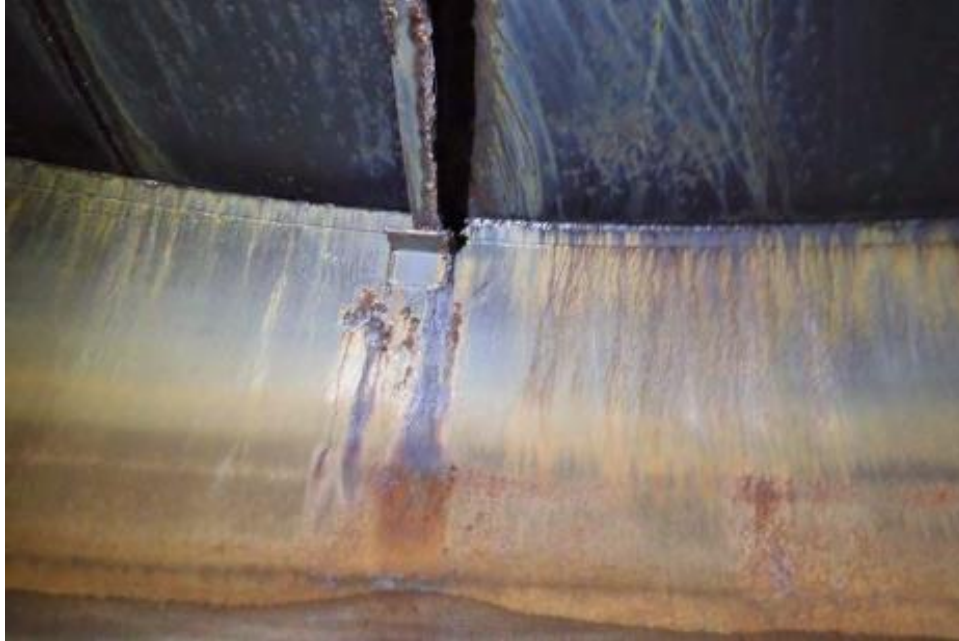
Figure 9-7. Example of Paloma Tank Interior Roof

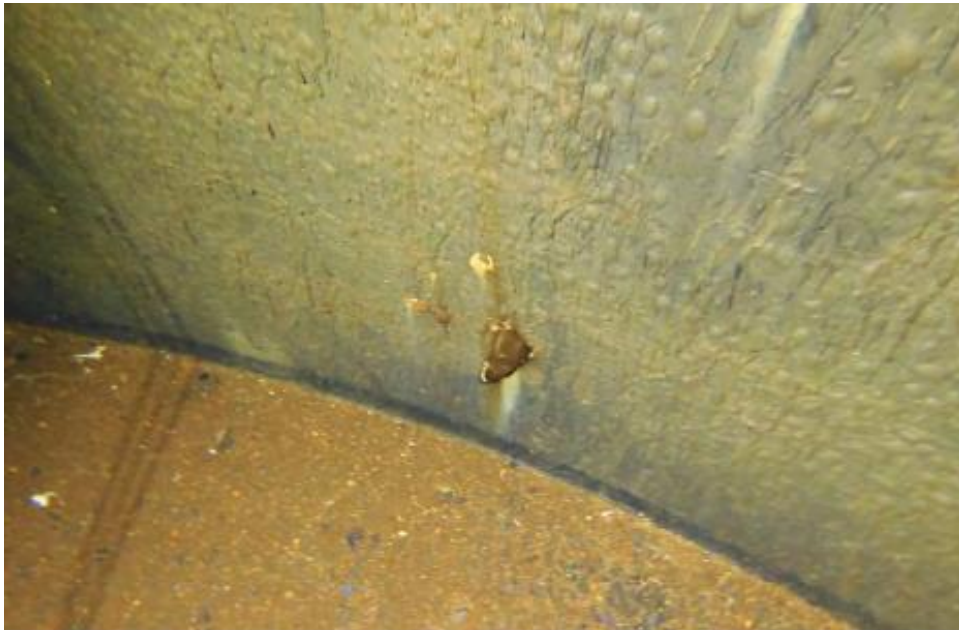
Figure 9-8. Example of Paloma Tank Interior Floor and Shell

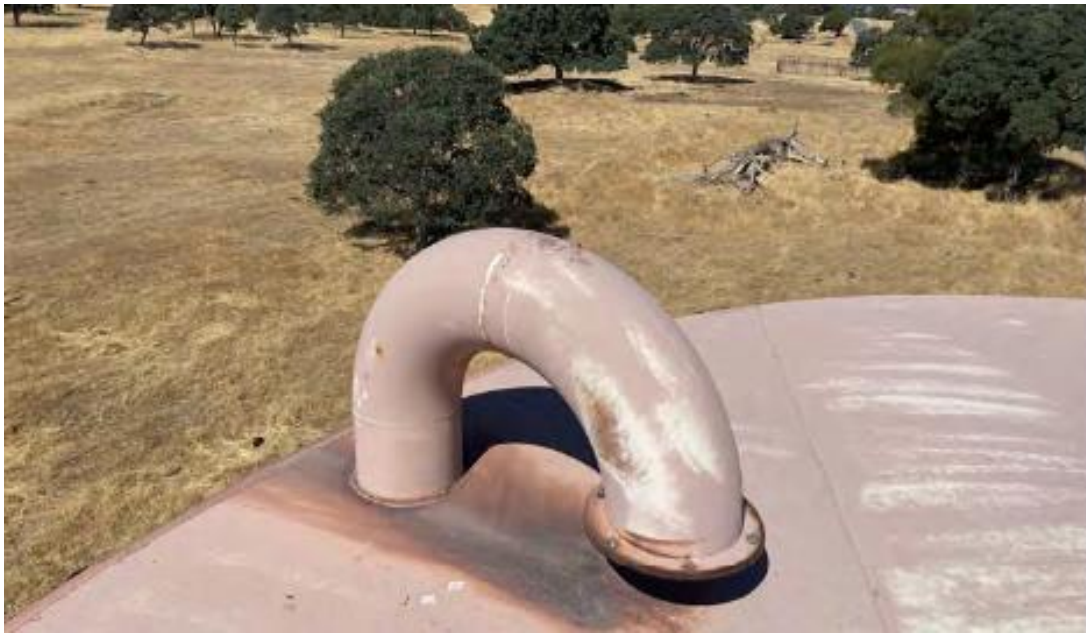
Figure 9-9. Example of Exterior Paloma Tank Roof

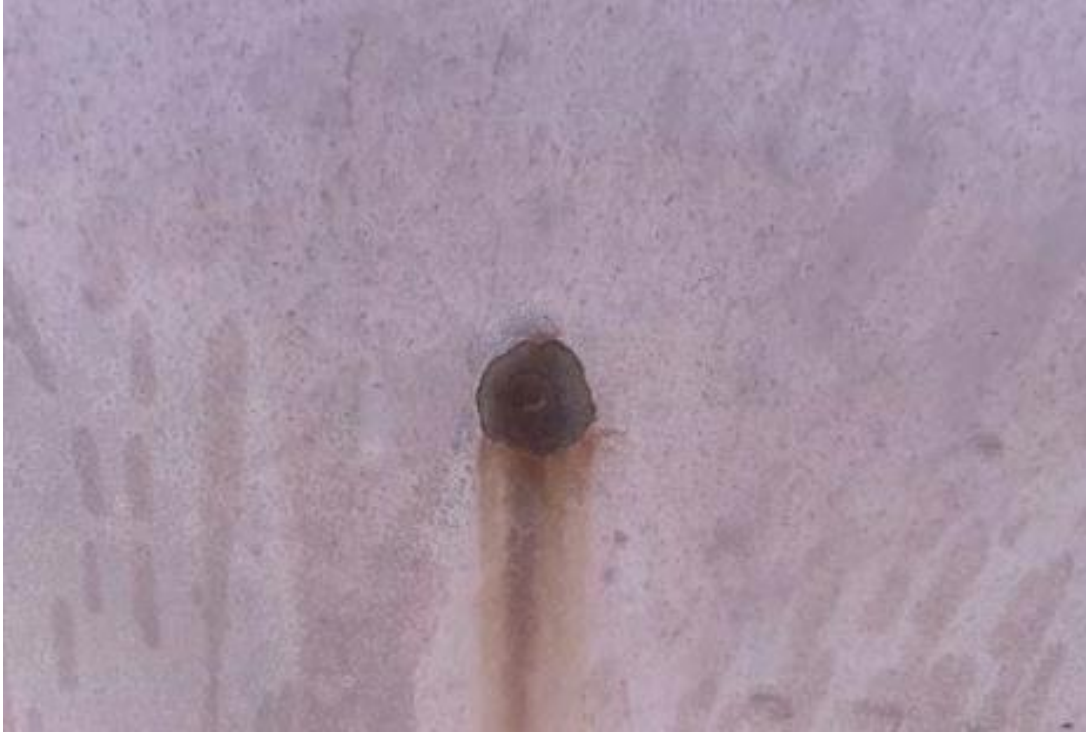
Figure 9-10. Example of Exterior Paloma Tank Shell

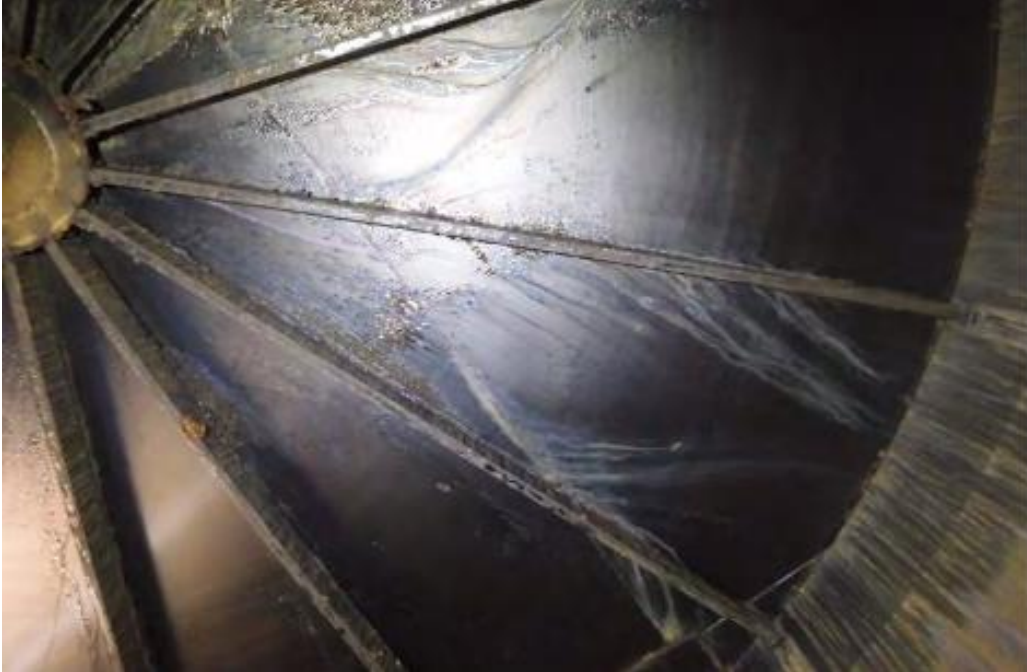
Figure 9-11. Example of Golden Hills Tank Interior Roof

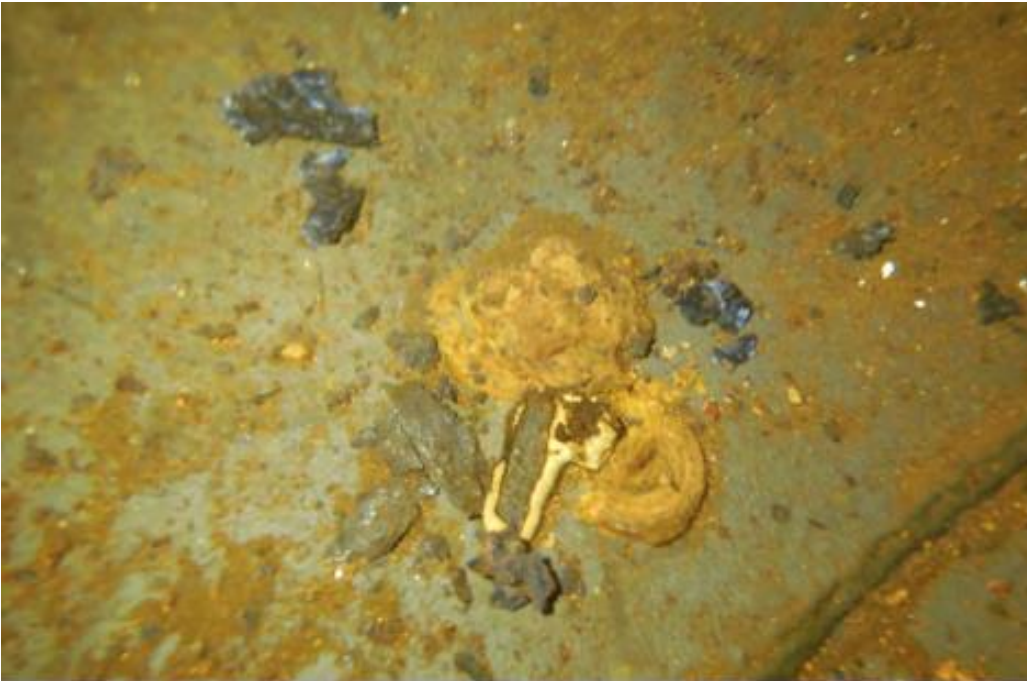
Figure 9-12. Example of Golden Hills Tank Interior Floor

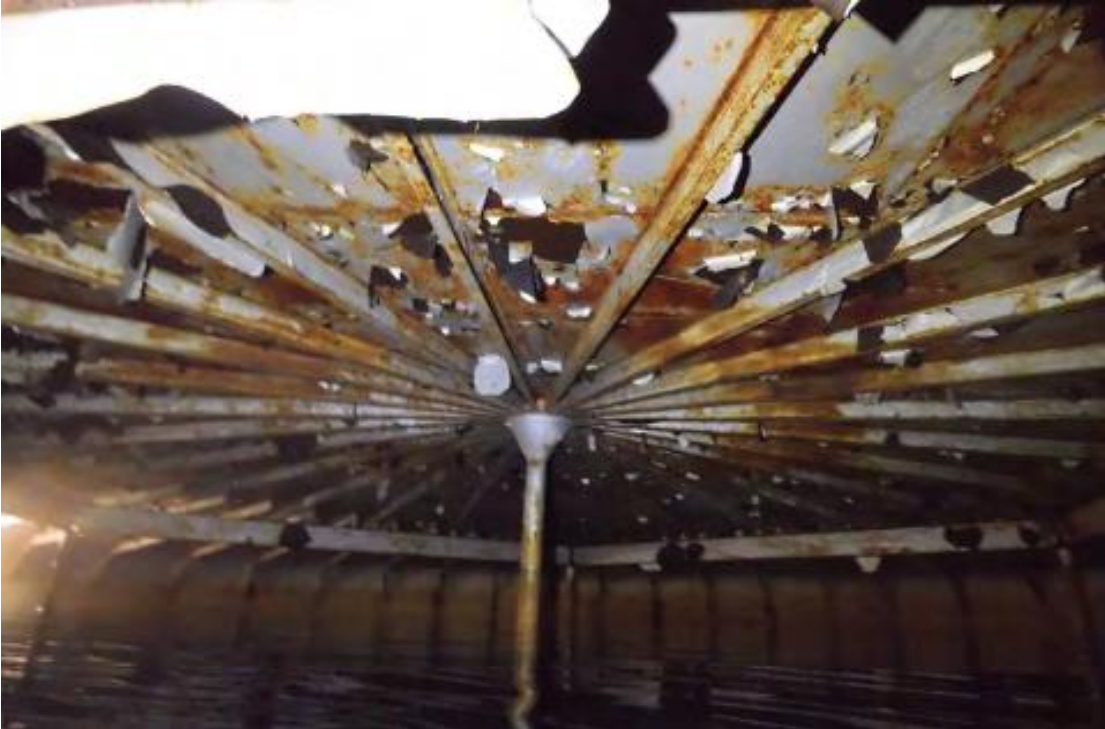
Figure 9-13. Example of San Andreas Tank Interior Roof

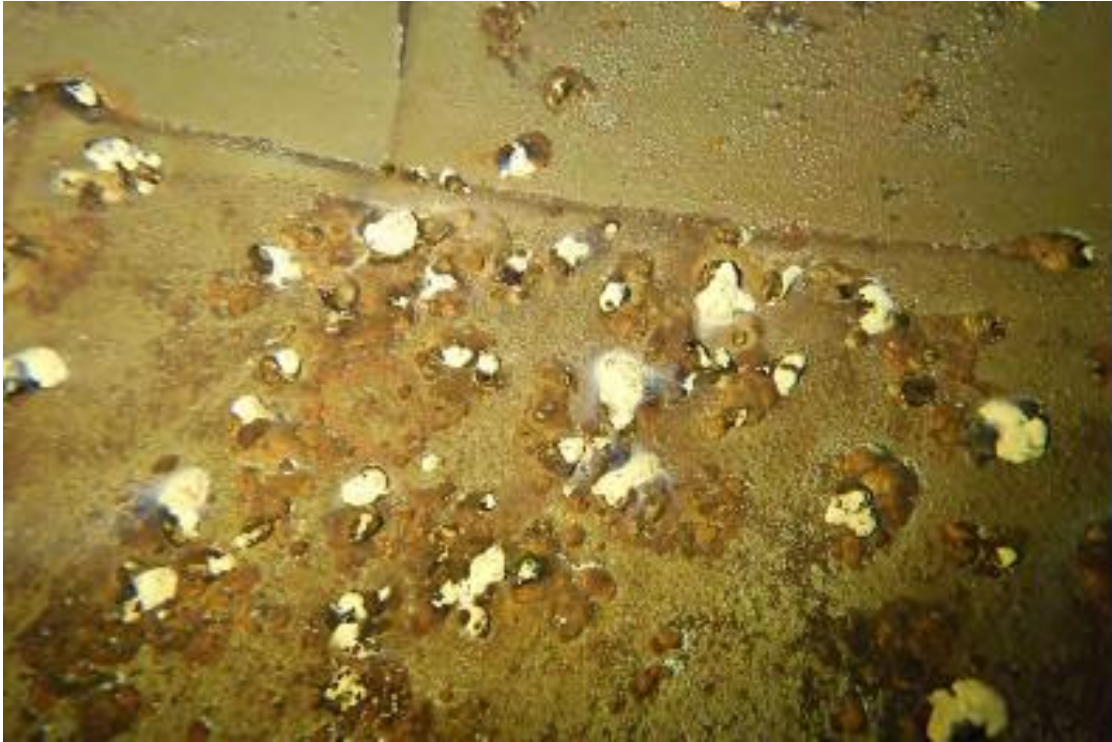
Figure 9-14. Example of San Andreas Tank Interior Floor

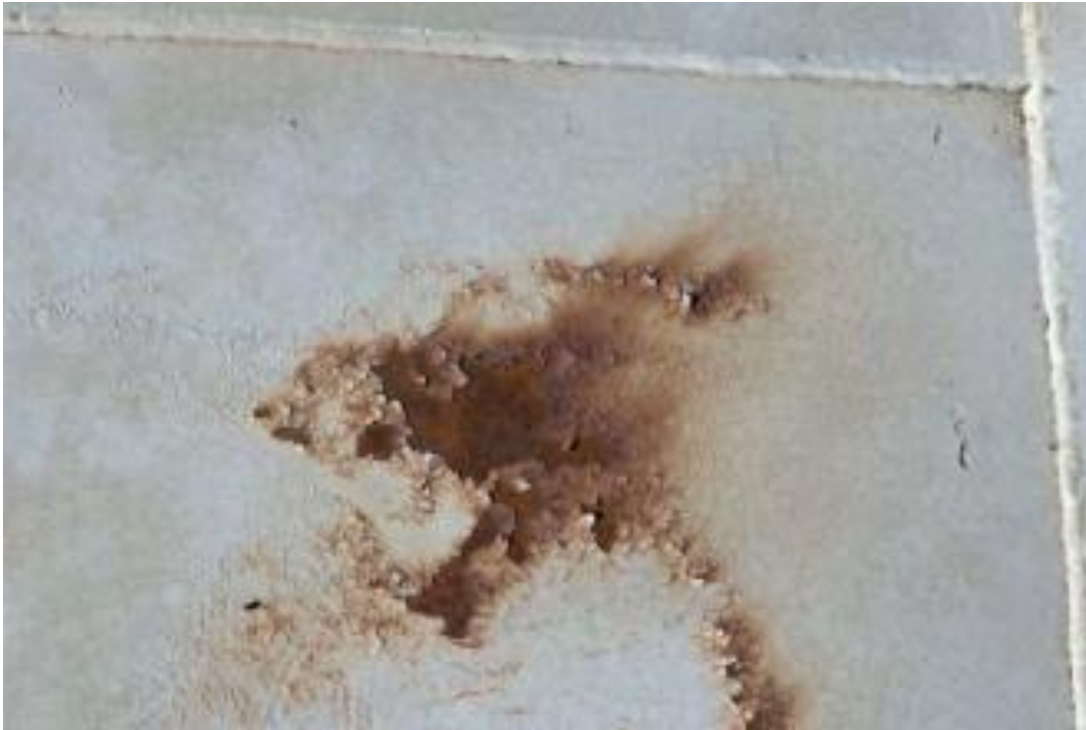
Figure 9-15. Example of San Andreas Tank Exterior Roof

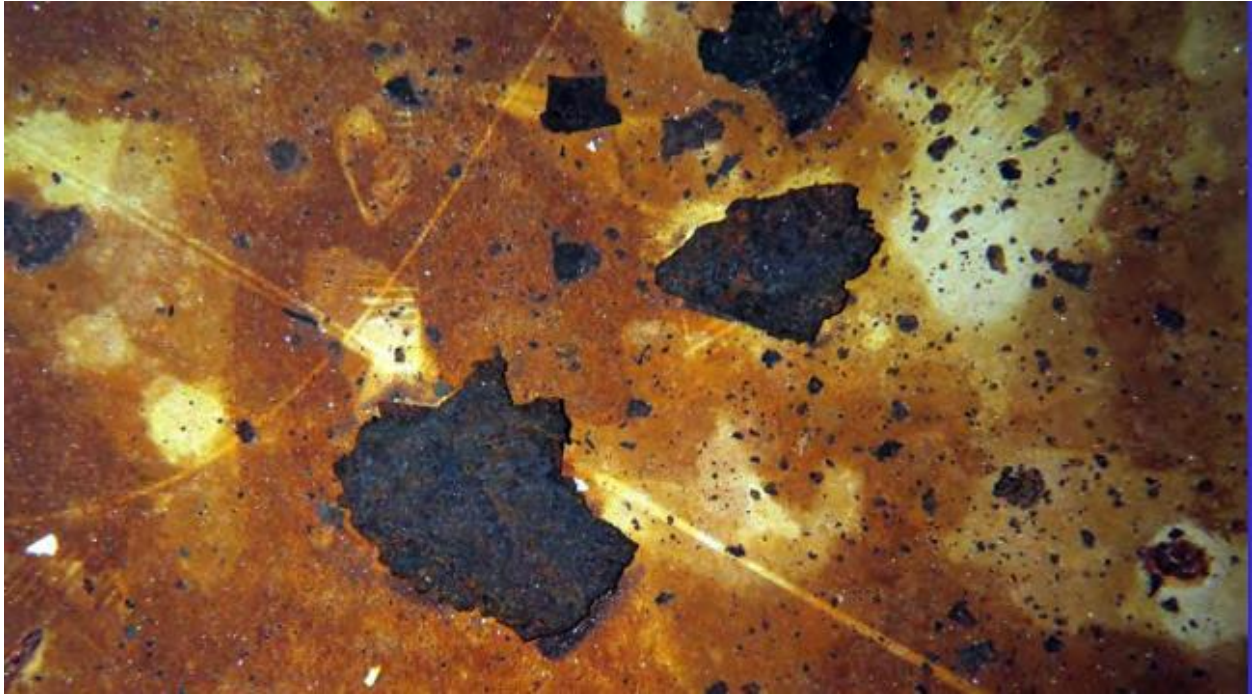
Figure 9-17. Clearwell Interior Corrosion Example (Floor)

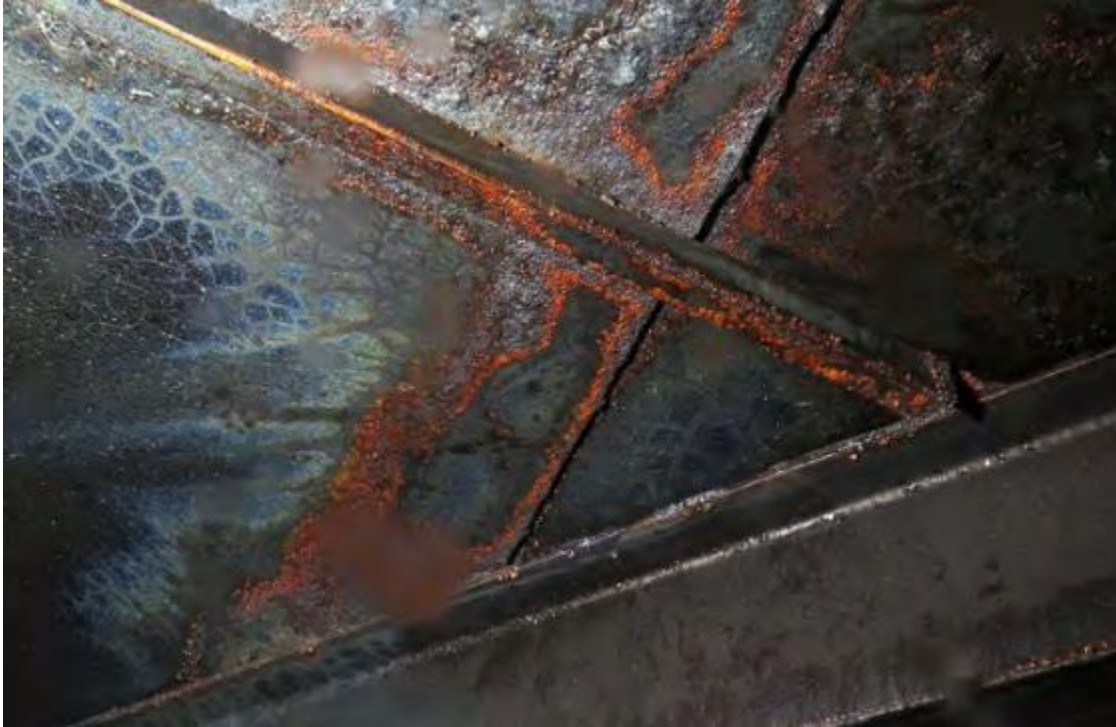
Figure 9-18. Clearwell Interior Corrosion Example (Roof)

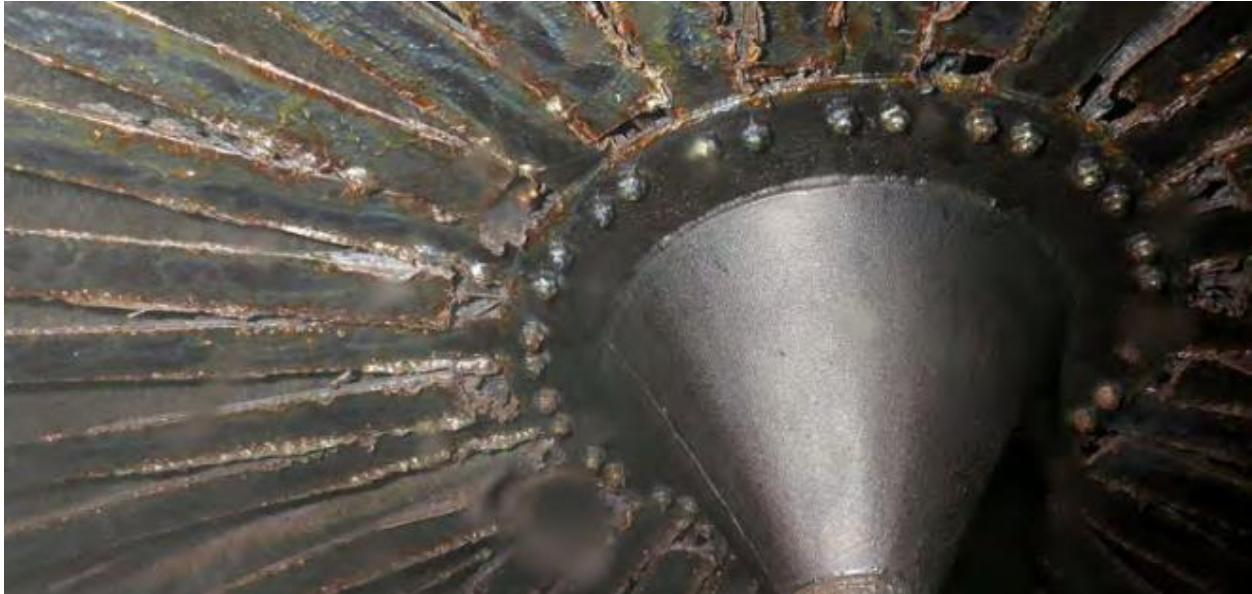
Figure 9-19. Clearwell Interior Corrosion Example (Roof Support)

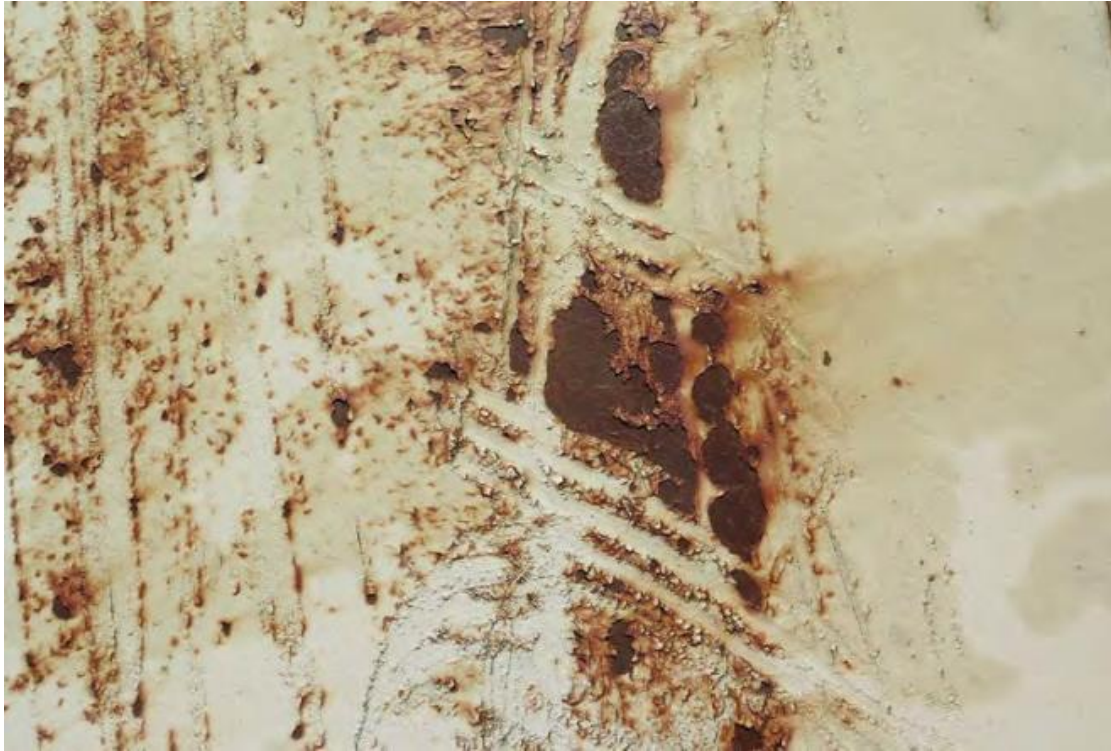
Figure 9-20. Clearwell Exterior Corrosion Example (Roof)

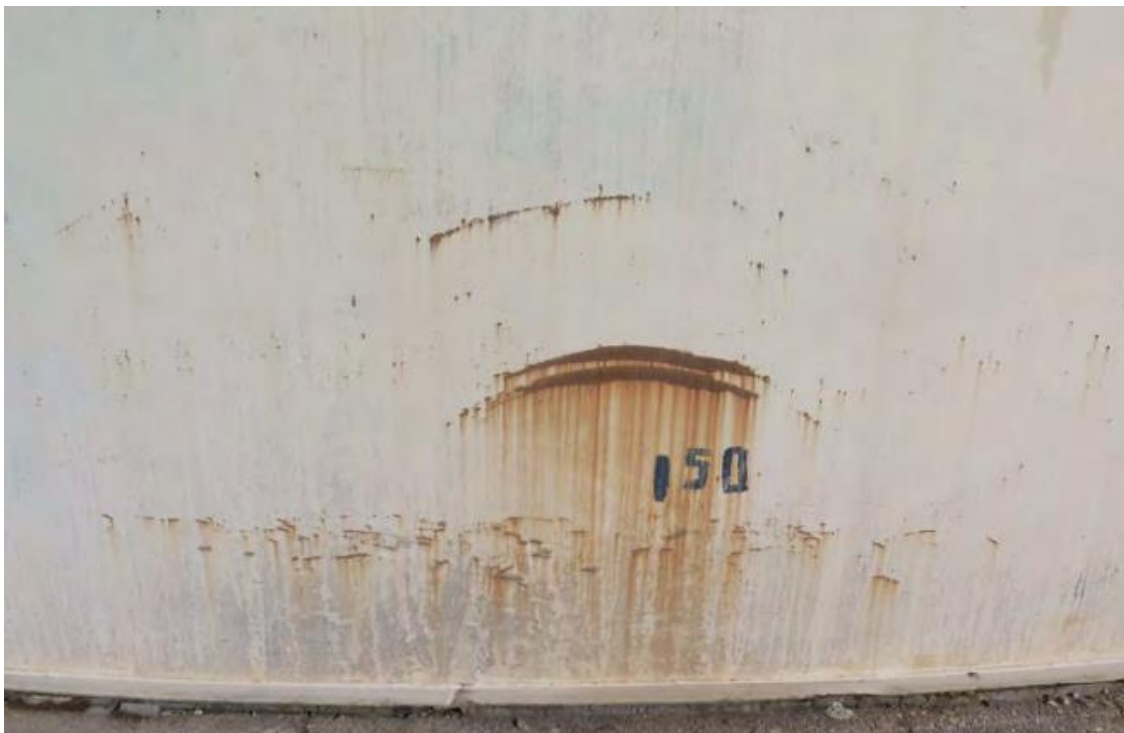
Figure 9-21. Clearwell Exterior Corrosion Example (Sidewall)

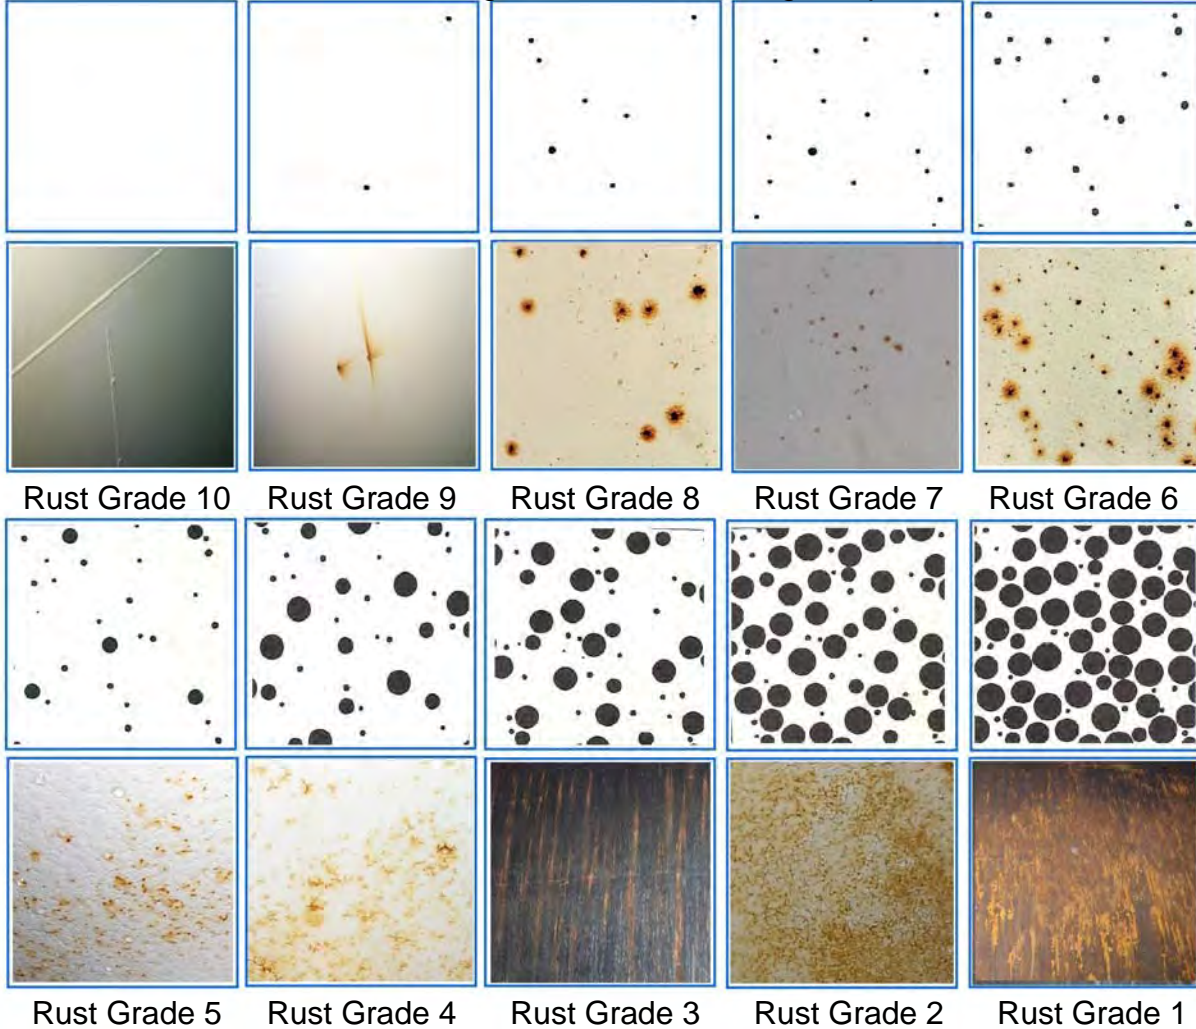
Chart 2 -Rust Grade The black and white figures below depict the standards referenced in ASTM D610 “Standard Test Method for Evaluating Degree of Rusting on Painted Surfaces.” Below each standard is a photographic depiction of each level of corrosion, as used by CSI Services, Inc. The standards depict the percentage of rust on a scale from 0 to 10, with 10 having no rust and 0 having complete rust.

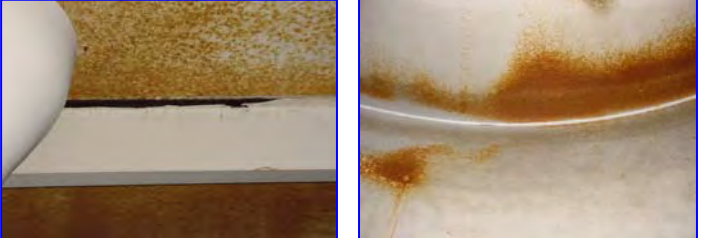
2	Dark Rust - This condition involves relatively dark colored, thicker rust that is progressing towards the next phase, significant metal loss.

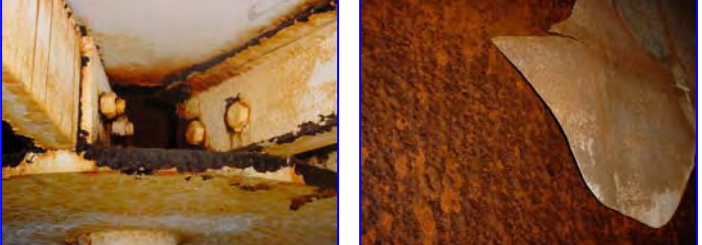
3	Pitting - This condition involves isolated or widespread deep spot corrosion (pitting).

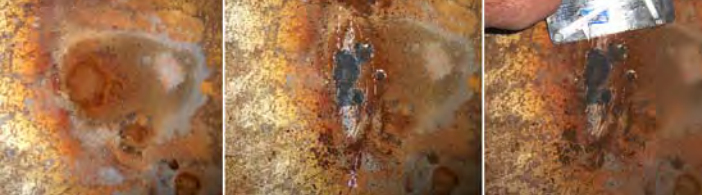
4	Scale - Also known as lamellar or exfoliation corrosion. The edges of the affected area are leaf like and resemble the separated pages of a wetted book.

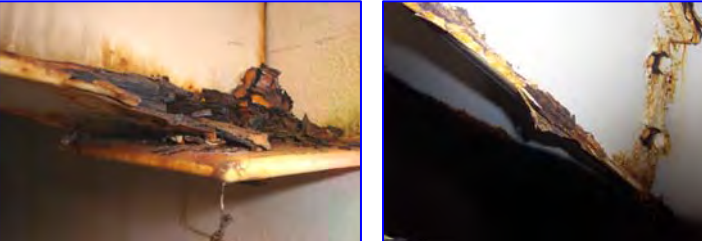
5	Structural Loss - This condition involves metal loss or failure where components will require structural consideration

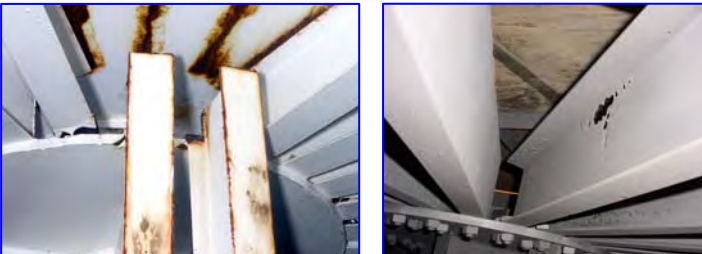
The photos depicted are examples and were not taken on this project.

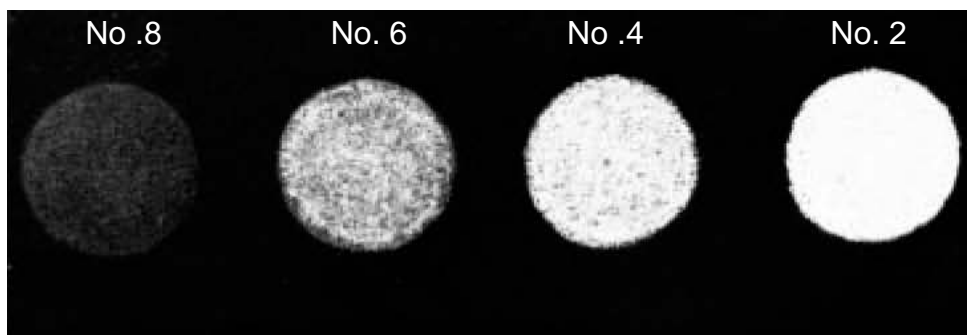
Light Colored Paints

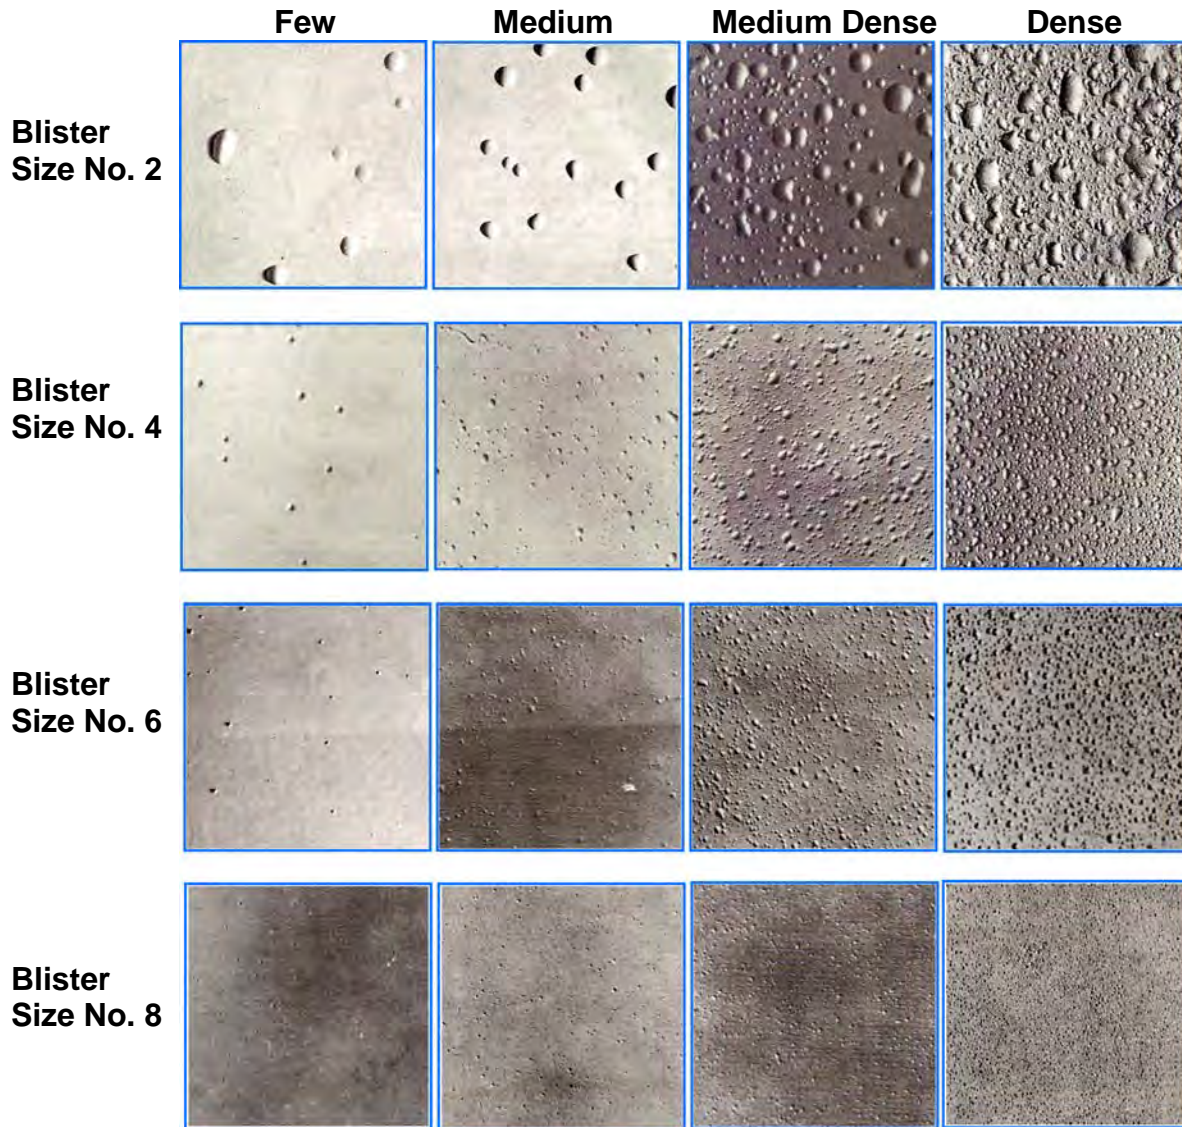
Chart 6 – Blistering Rating The figure below depicts the photographic standards referenced in ASTM D714 “Standard Test Method for Evaluating Degree of Blistering of Paints”. This test uses these pictorial standards to quantify both the size and density of blisters that may develop in linings. Although the standard uses a blister size scale of 0 to 10 this chart uses the most common sizes of blisters found in the field. The standard does not use a reference for the size of each of the blisters depicted. CSI used this scale as a means for further quantification by qualifying the largest blister depicted as being 1 inch in width (Blister Size No. 2) and the smallest blister being 1/32 of an inch in width (Blister Size No. 8).

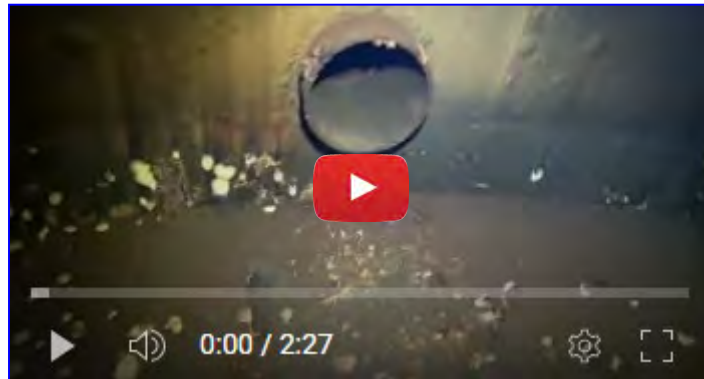
Click on link or cut and paste the external link: <https://youtu.be/NH0eloaUTho>

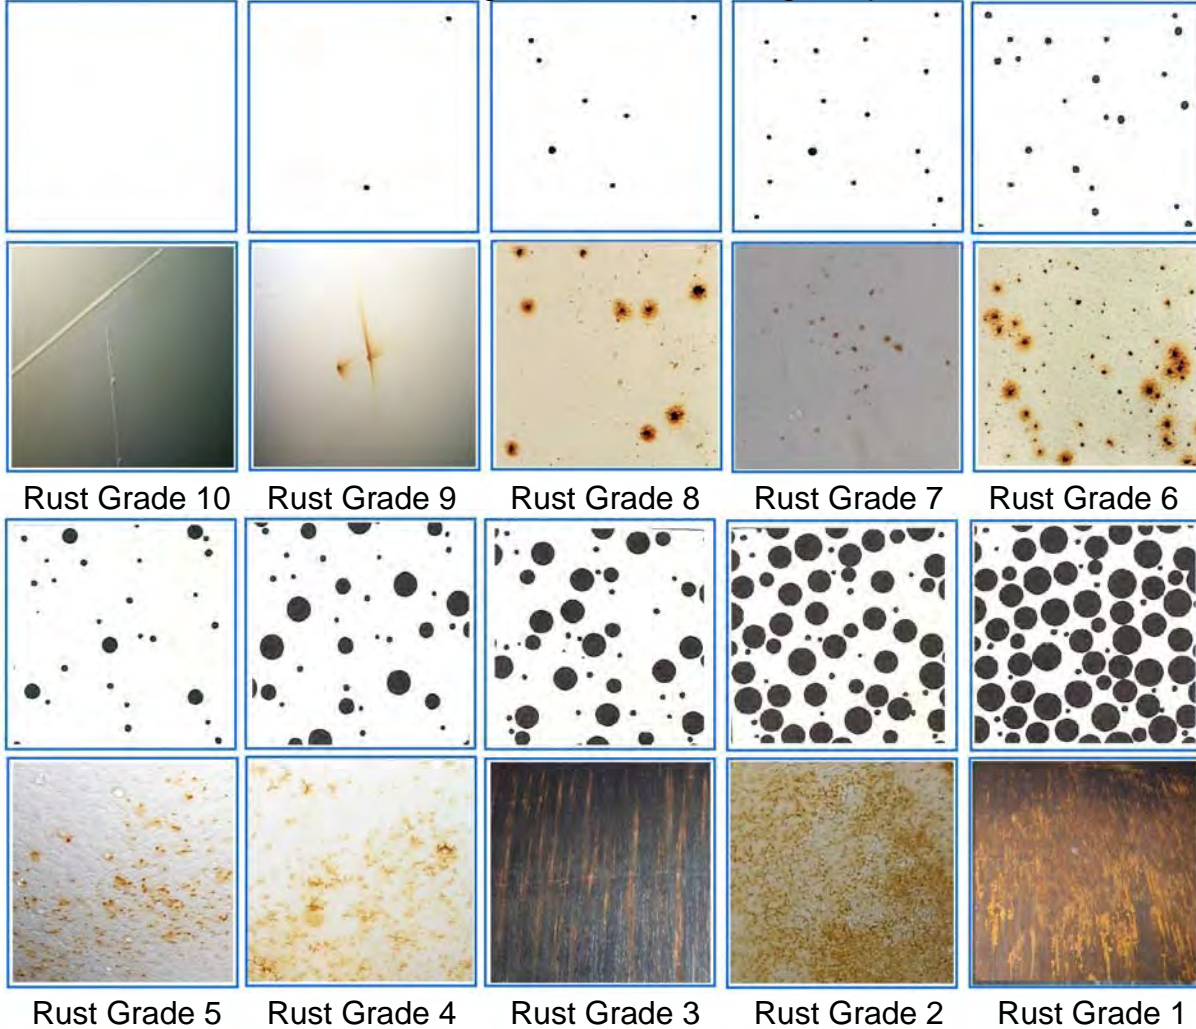
Chart 2 -Rust Grade The black and white figures below depict the standards referenced in ASTM D610 “Standard Test Method for Evaluating Degree of Rusting on Painted Surfaces.” Below each standard is a photographic depiction of each level of corrosion, as used by CSI Services, Inc. The standards depict the percentage of rust on a scale from 0 to 10, with 10 having no rust and 0 having complete rust.

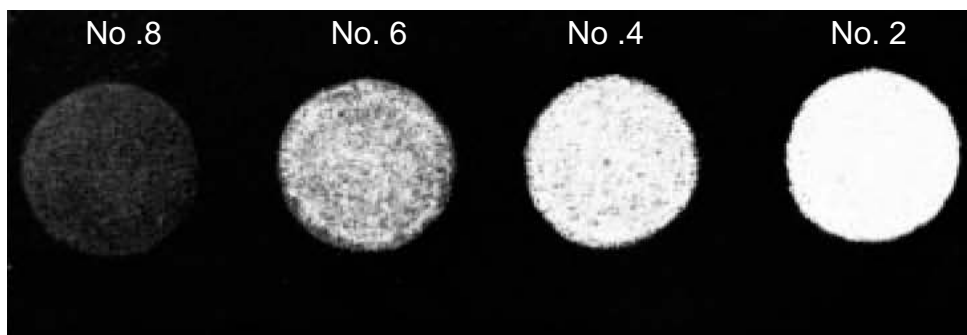
Light Colored Paints

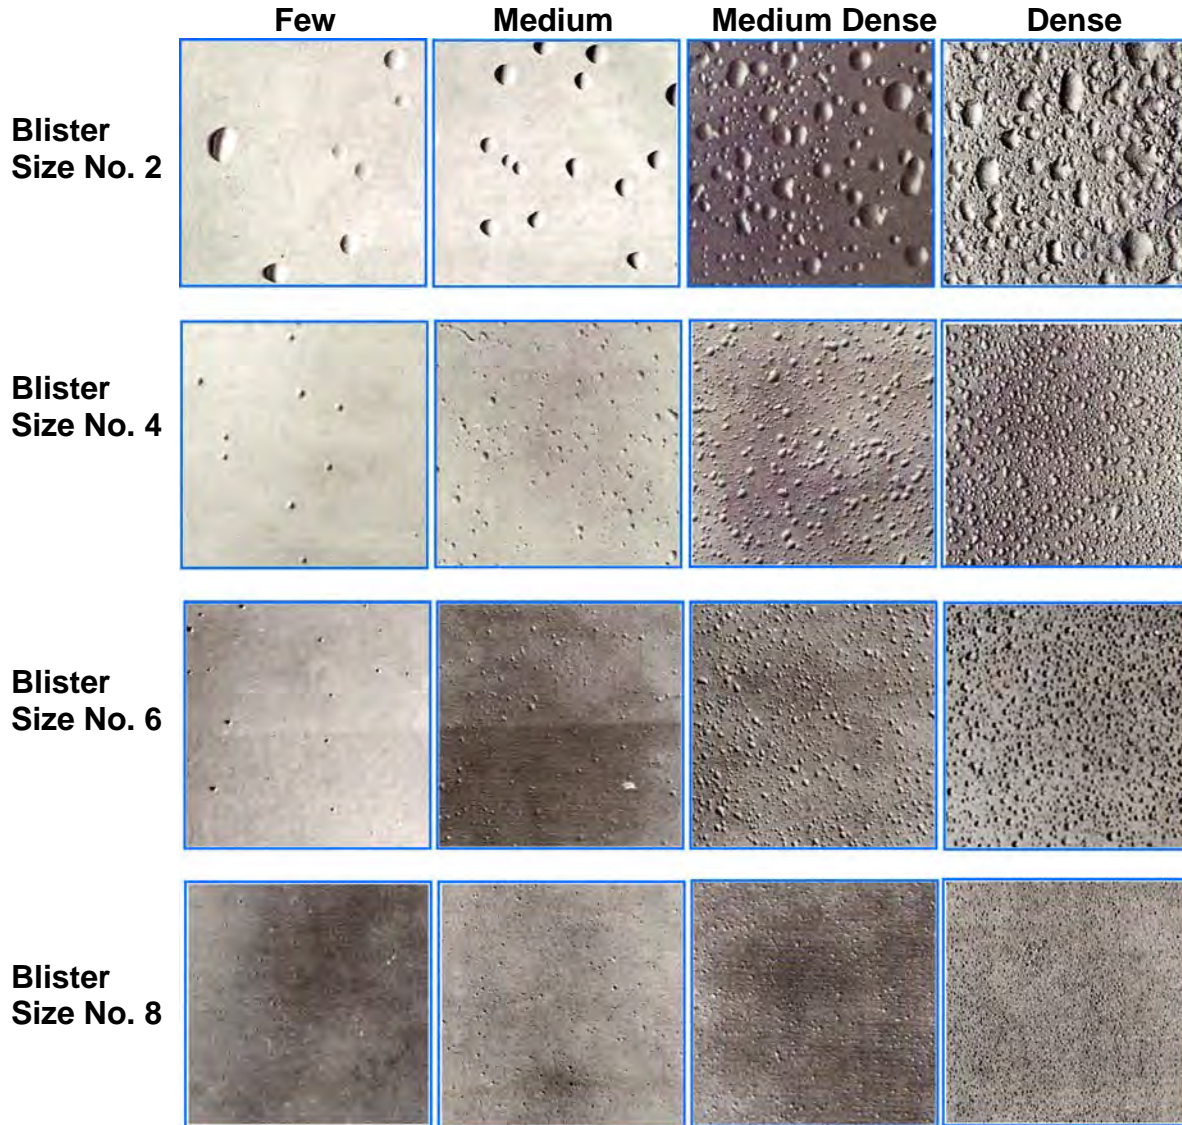
Chart 6 – Blistering Rating The figure below depicts the photographic standards referenced in ASTM D714 “Standard Test Method for Evaluating Degree of Blistering of Paints”. This test uses these pictorial standards to quantify both the size and density of blisters that may develop in linings. Although the standard uses a blister size scale of 0 to 10 this chart uses the most common sizes of blisters found in the field. The standard does not use a reference for the size of each of the blisters depicted. CSI used this scale as a means for further quantification by qualifying the largest blister depicted as being 1 inch in width (Blister Size No. 2) and the smallest blister being 1/32 of an inch in width (Blister Size No. 8).

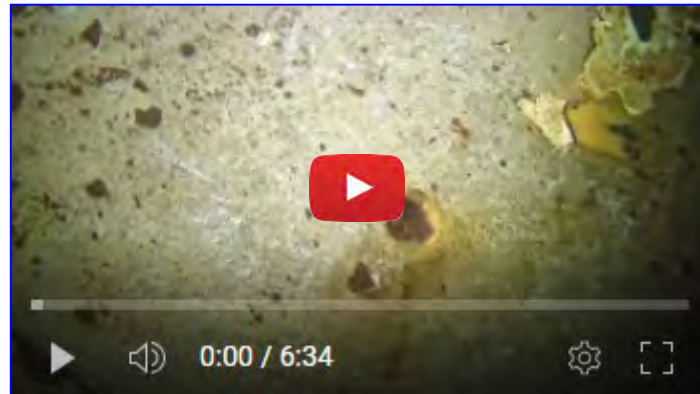
Click on link or cut and paste the external link: <https://youtu.be/UShHmflrSaY>
