CALAVERAS PUBLIC UTILITY DISTRICT

2024 WATER MASTER PLAN UPDATE

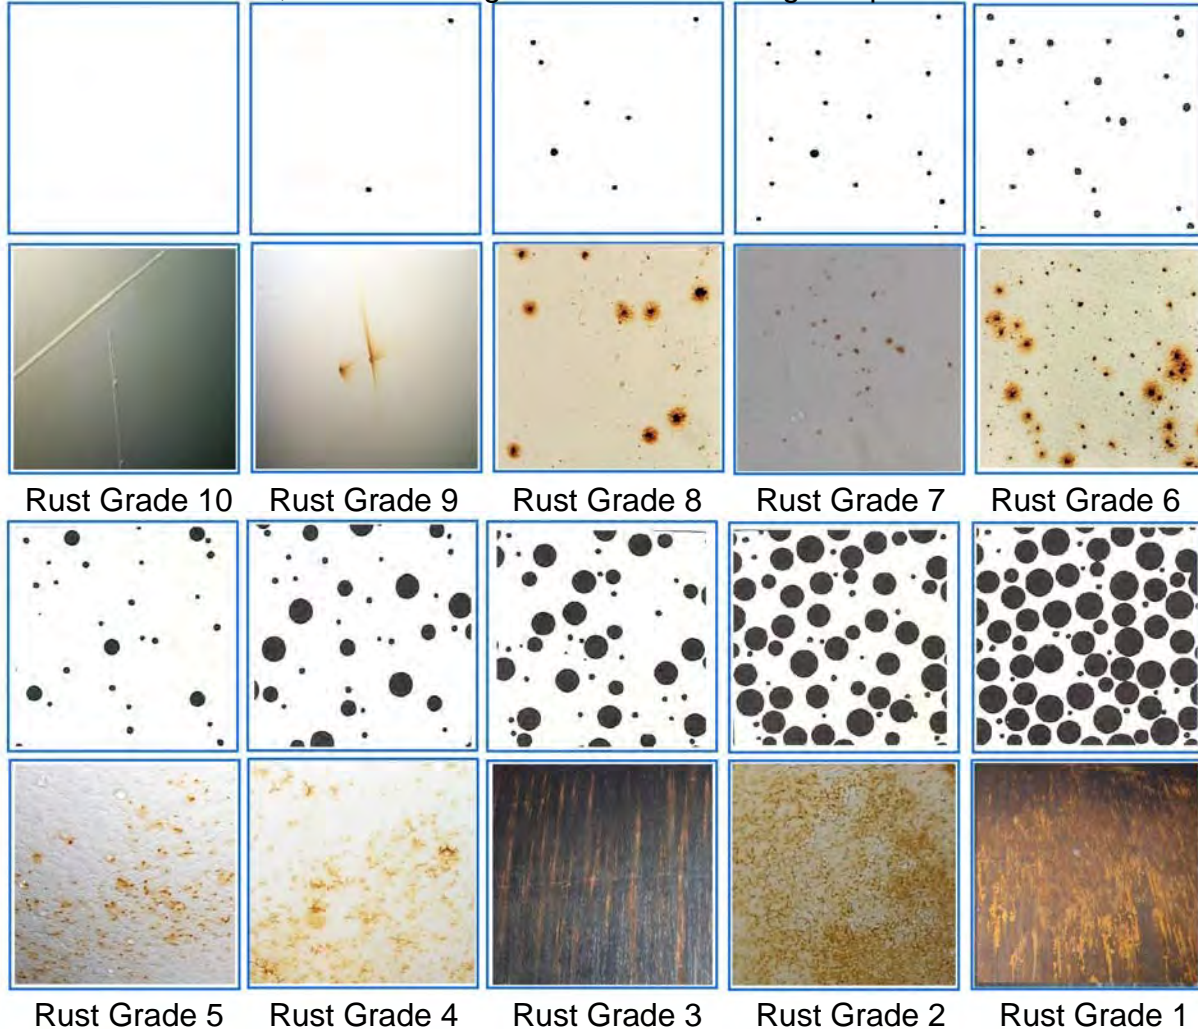
Chart 2 -Rust Grade The black and white figures below depict the standards referenced in ASTM D610 “Standard Test Method for Evaluating Degree of Rusting on Painted Surfaces.” Below each standard is a photographic depiction of each level of corrosion, as used by CSI Services, Inc. The standards depict the percentage of rust on a scale from 0 to 10, with 10 having no rust and 0 having complete rust.

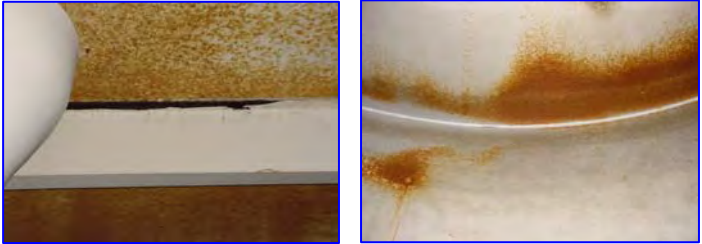
2	Dark Rust - This condition involves relatively dark colored, thicker rust that is progressing towards the next phase, significant metal loss.

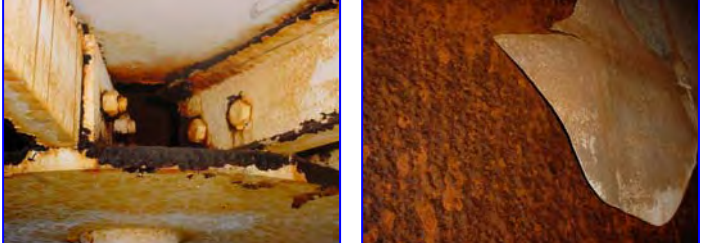
3	Pitting - This condition involves isolated or widespread deep spot corrosion (pitting).

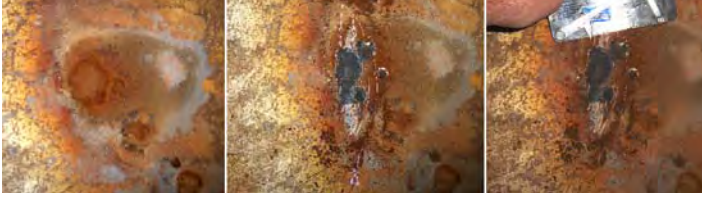
4	Scale - Also known as lamellar or exfoliation corrosion. The edges of the affected area are leaf like and resemble the separated pages of a wetted book.

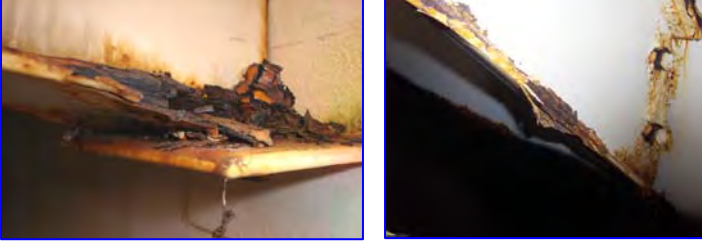
5	Structural Loss - This condition involves metal loss or failure where components will require structural consideration

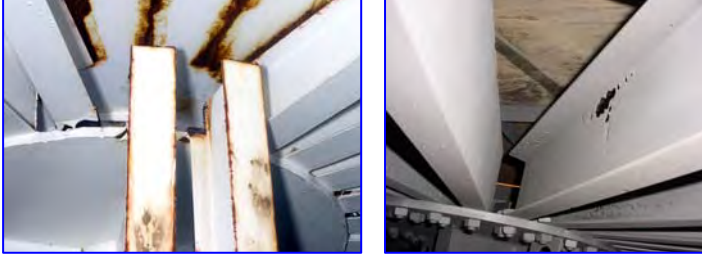
The photos depicted are examples and were not taken on this project.

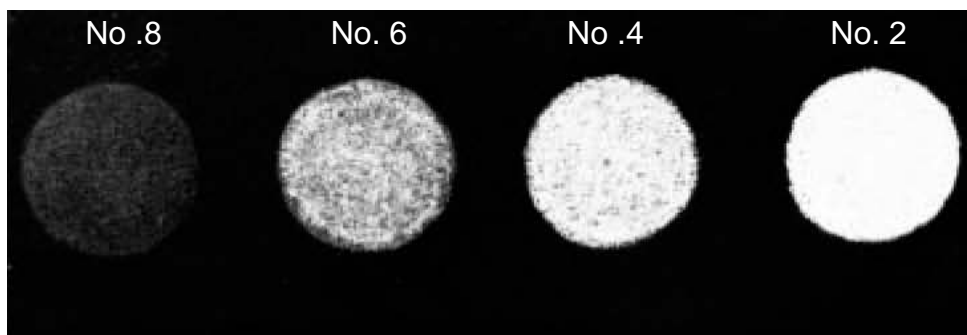
Light Colored Paints

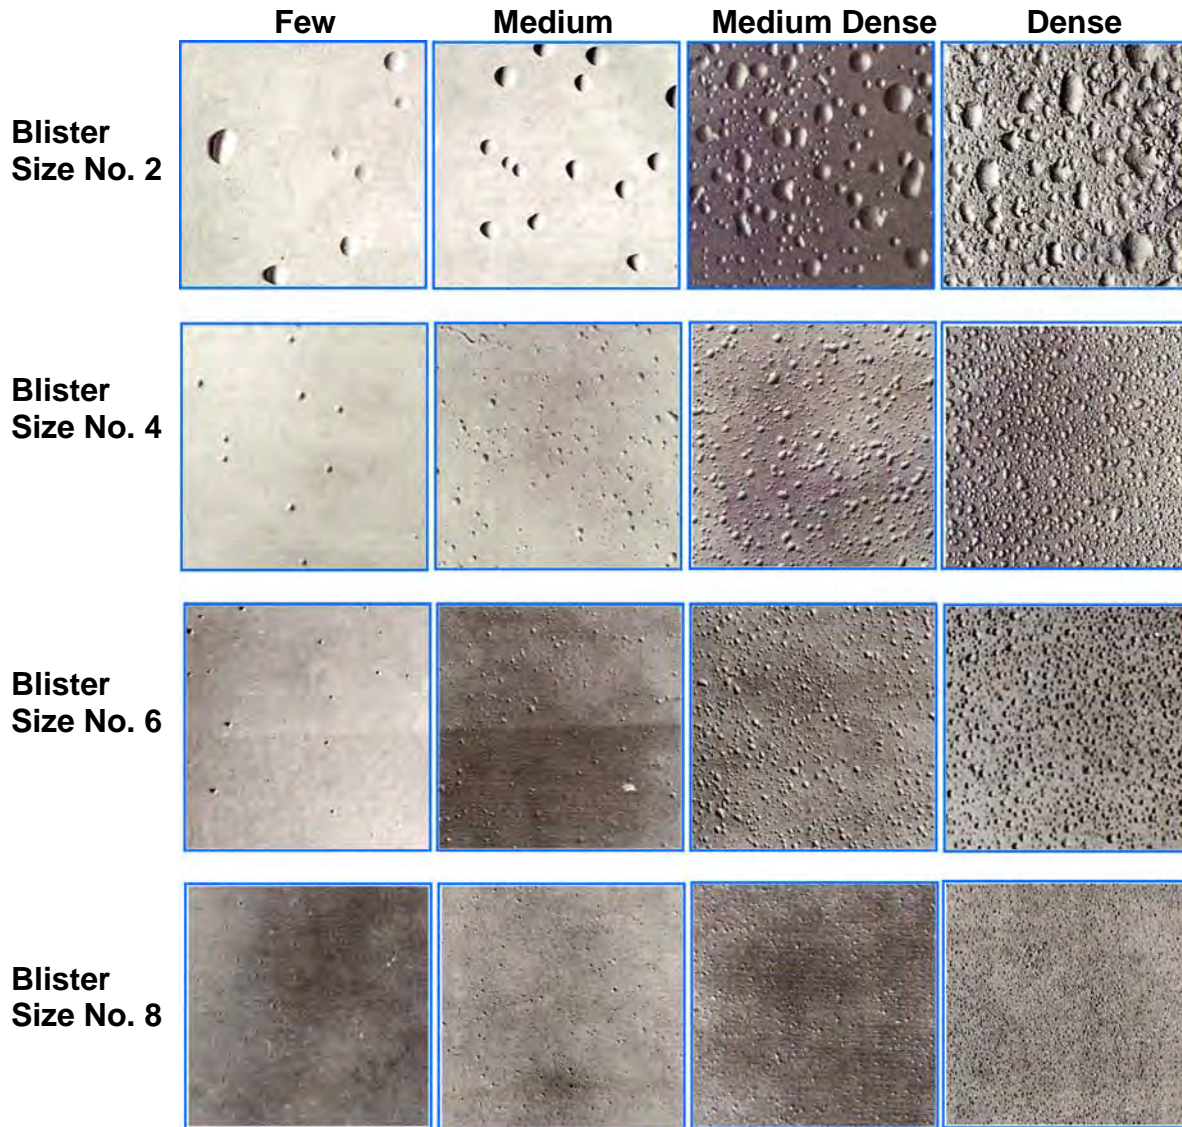
Chart 6 – Blistering Rating The figure below depicts the photographic standards referenced in ASTM D714 “Standard Test Method for Evaluating Degree of Blistering of Paints”. This test uses these pictorial standards to quantify both the size and density of blisters that may develop in linings. Although the standard uses a blister size scale of 0 to 10 this chart uses the most common sizes of blisters found in the field. The standard does not use a reference for the size of each of the blisters depicted. CSI used this scale as a means for further quantification by qualifying the largest blister depicted as being 1 inch in width (Blister Size No. 2) and the smallest blister being 1/32 of an inch in width (Blister Size No. 8).

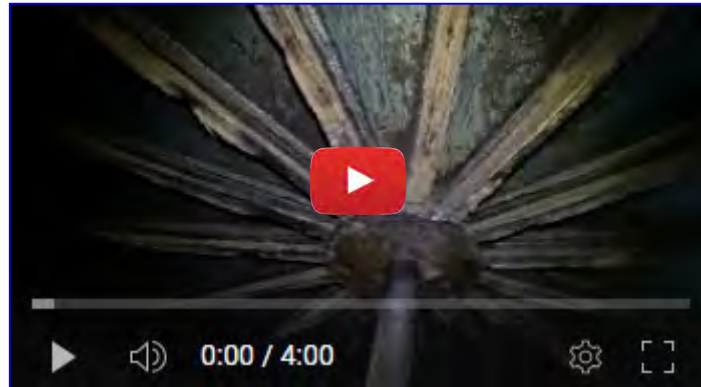
Click on link or cut and paste the external link: <https://youtu.be/SBcayd1PcEg>

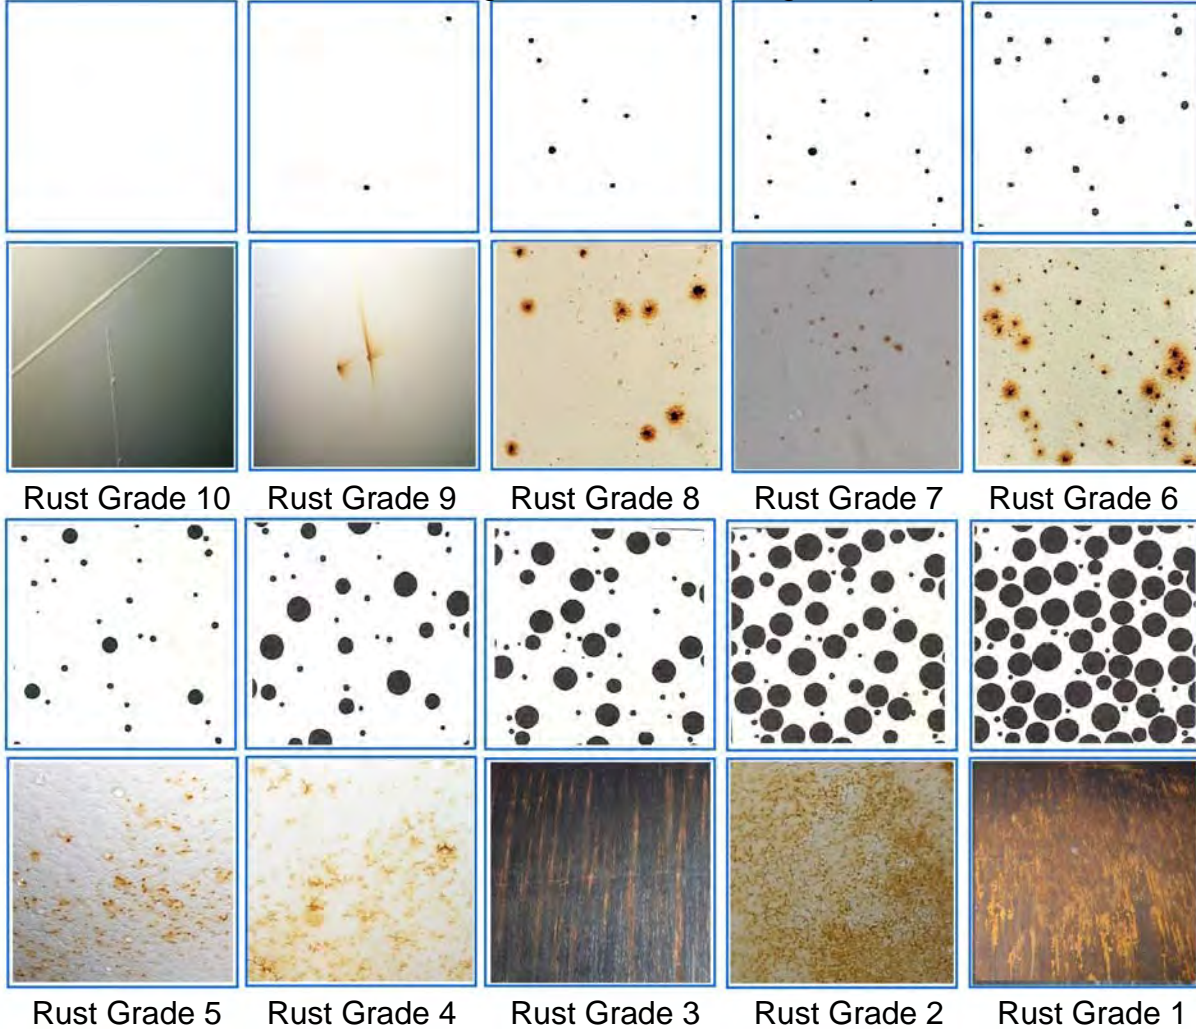
Chart 2 -Rust Grade The black and white figures below depict the standards referenced in ASTM D610 “Standard Test Method for Evaluating Degree of Rusting on Painted Surfaces.” Below each standard is a photographic depiction of each level of corrosion, as used by CSI Services, Inc. The standards depict the percentage of rust on a scale from 0 to 10, with 10 having no rust and 0 having complete rust.

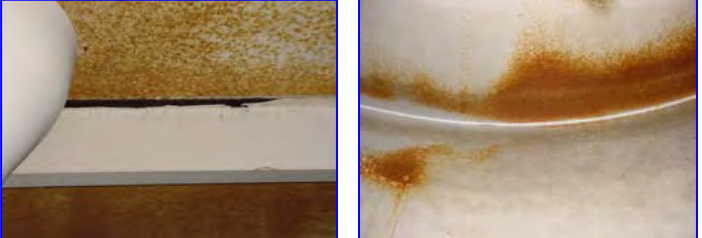
2	Dark Rust - This condition involves relatively dark colored, thicker rust that is progressing towards the next phase, significant metal loss.

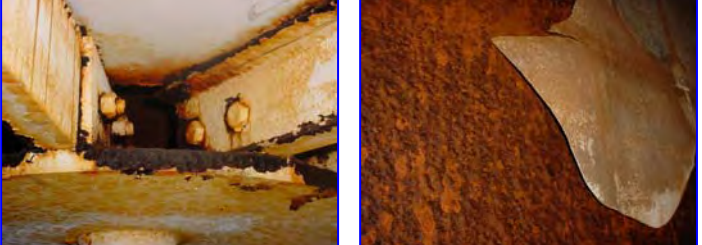
3	Pitting - This condition involves isolated or widespread deep spot corrosion (pitting).

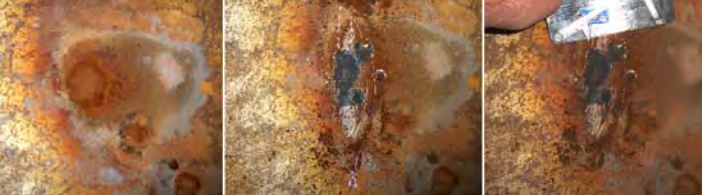
4	Scale - Also known as lamellar or exfoliation corrosion. The edges of the affected area are leaf like and resemble the separated pages of a wetted book.

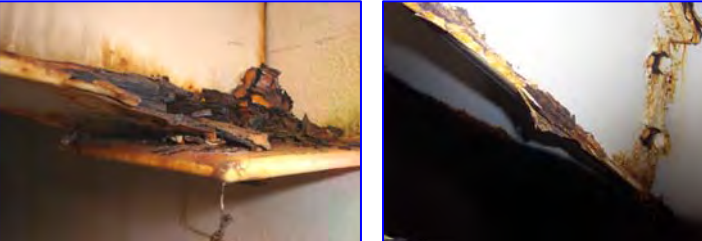
5	Structural Loss - This condition involves metal loss or failure where components will require structural consideration

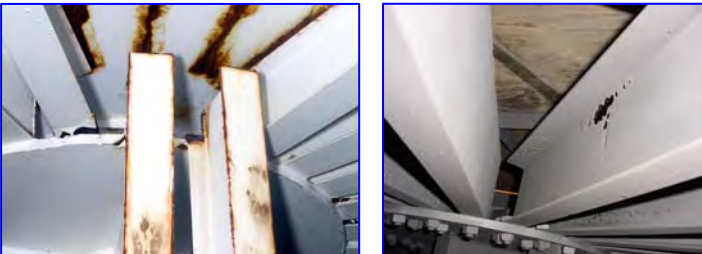
The photos depicted are examples and were not taken on this project.

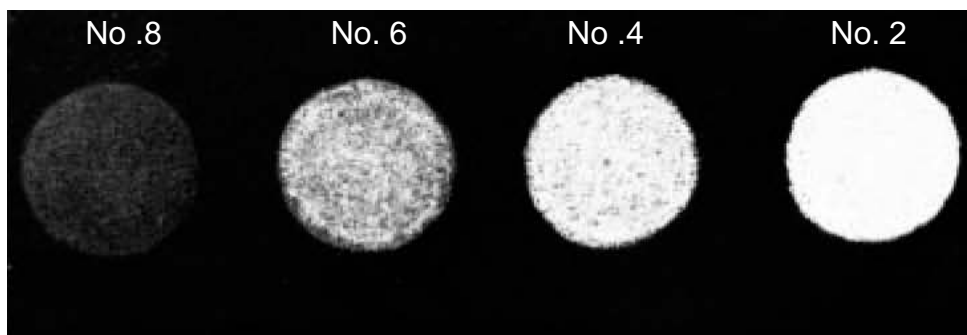
Light Colored Paints

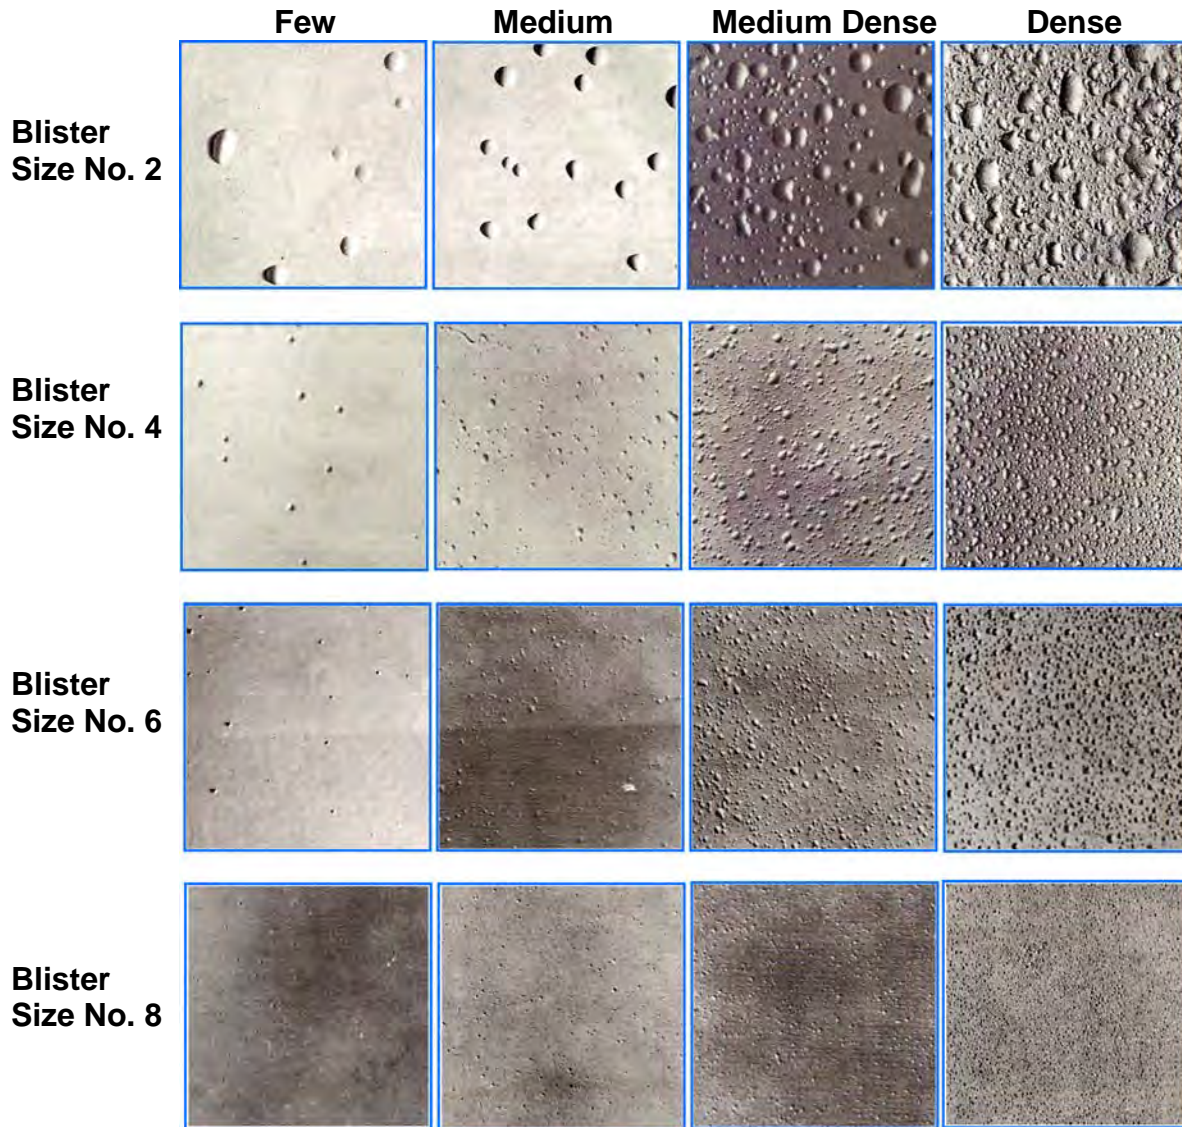
Chart 6 – Blistering Rating The figure below depicts the photographic standards referenced in ASTM D714 “Standard Test Method for Evaluating Degree of Blistering of Paints”. This test uses these pictorial standards to quantify both the size and density of blisters that may develop in linings. Although the standard uses a blister size scale of 0 to 10 this chart uses the most common sizes of blisters found in the field. The standard does not use a reference for the size of each of the blisters depicted. CSI used this scale as a means for further quantification by qualifying the largest blister depicted as being 1 inch in width (Blister Size No. 2) and the smallest blister being 1/32 of an inch in width (Blister Size No. 8).

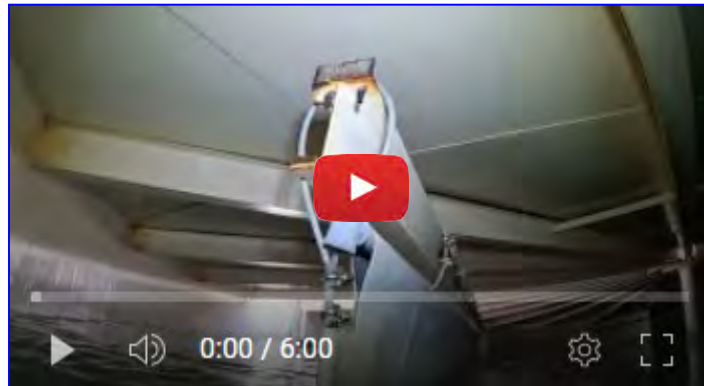
Click on link or cut and paste the external link: <https://youtu.be/gco8B3lgk84>

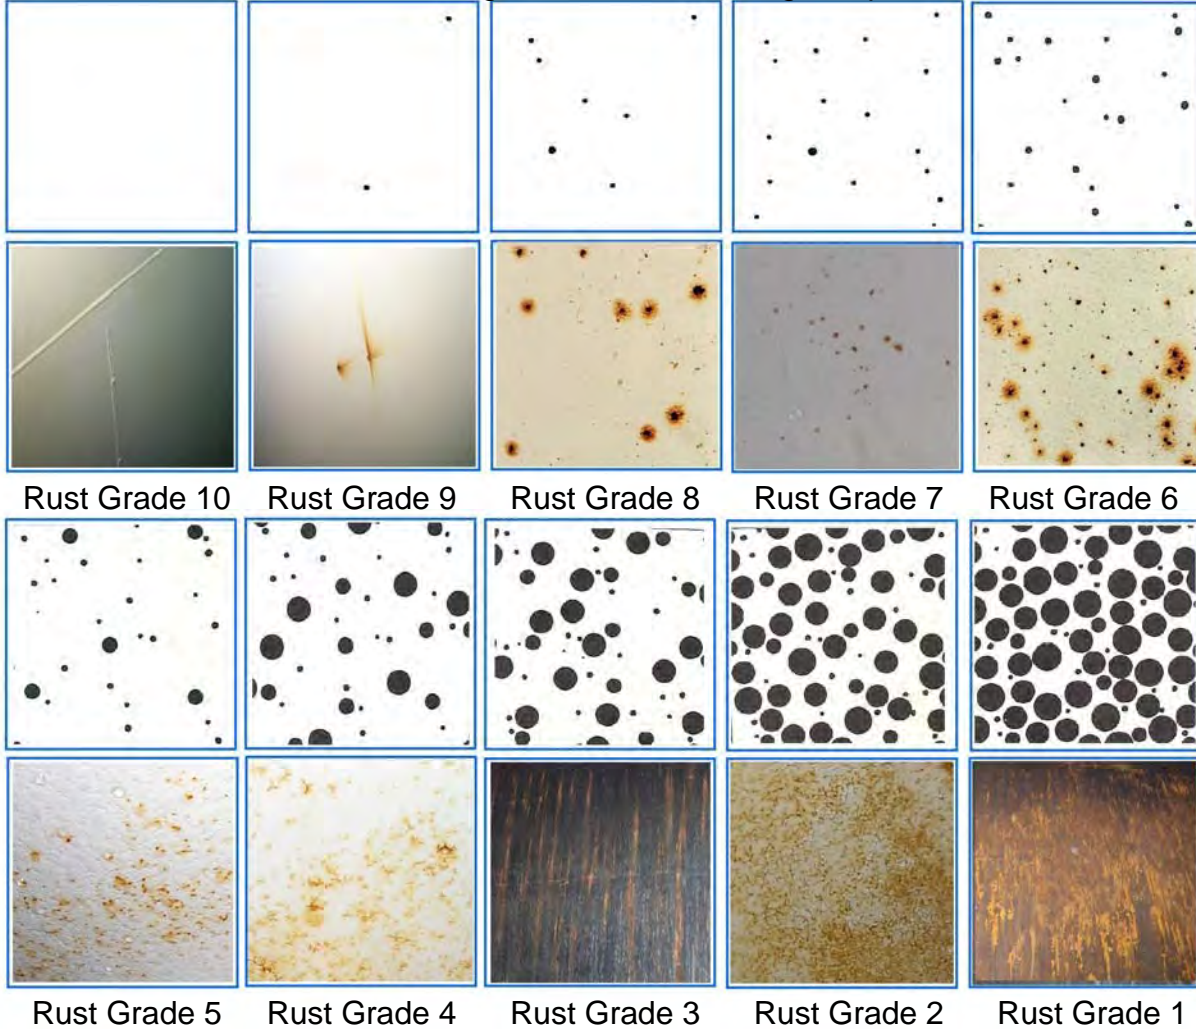
Chart 2 -Rust Grade The black and white figures below depict the standards referenced in ASTM D610 “Standard Test Method for Evaluating Degree of Rusting on Painted Surfaces.” Below each standard is a photographic depiction of each level of corrosion, as used by CSI Services, Inc. The standards depict the percentage of rust on a scale from 0 to 10, with 10 having no rust and 0 having complete rust.

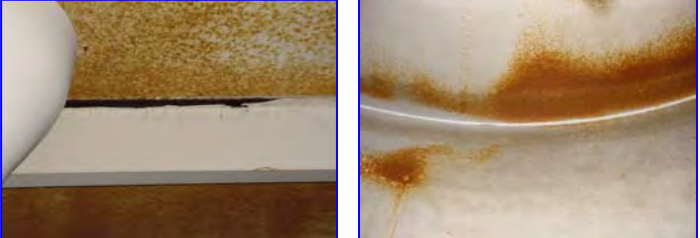
2	Dark Rust - This condition involves relatively dark colored, thicker rust that is progressing towards the next phase, significant metal loss.

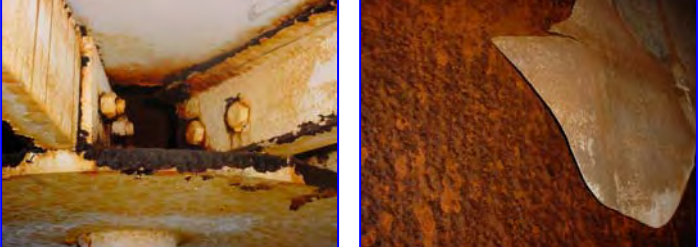
3	Pitting - This condition involves isolated or widespread deep spot corrosion (pitting).

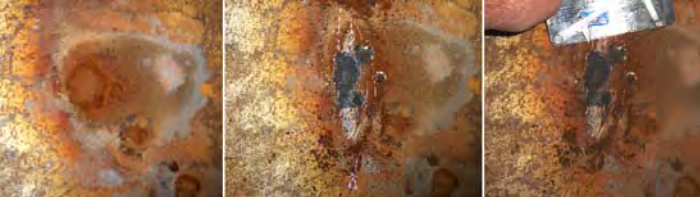
4	Scale - Also known as lamellar or exfoliation corrosion. The edges of the affected area are leaf like and resemble the separated pages of a wetted book.

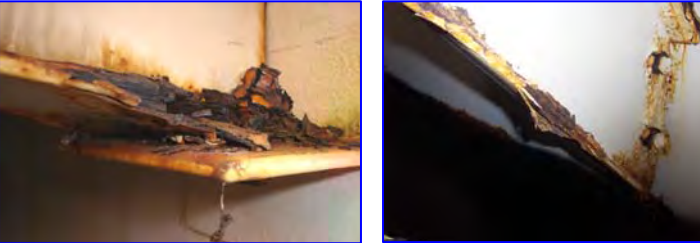
5	Structural Loss - This condition involves metal loss or failure where components will require structural consideration

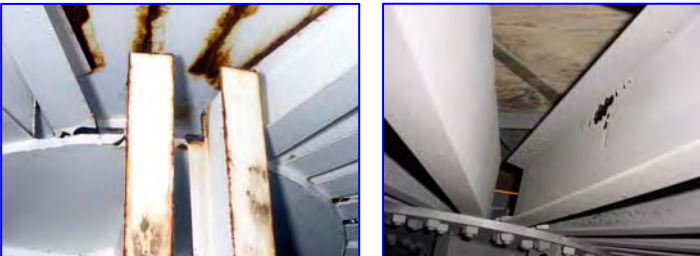
The photos depicted are examples and were not taken on this project.

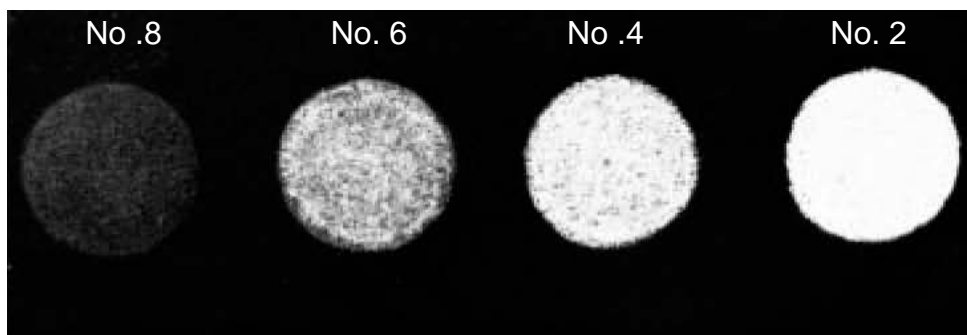
Light Colored Paints

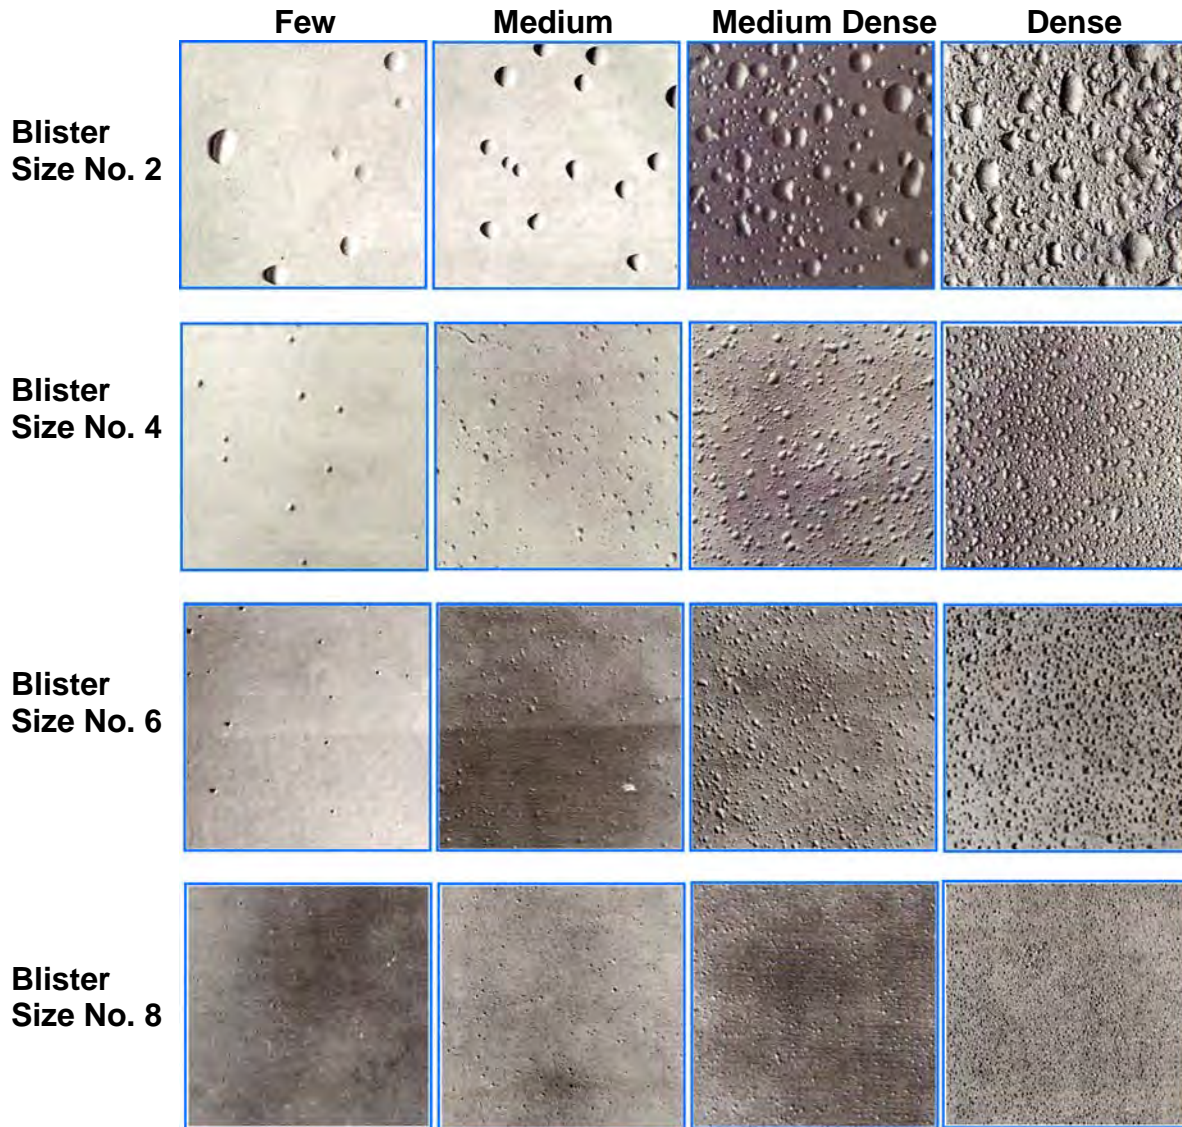
Chart 6 – Blistering Rating The figure below depicts the photographic standards referenced in ASTM D714 “Standard Test Method for Evaluating Degree of Blistering of Paints”. This test uses these pictorial standards to quantify both the size and density of blisters that may develop in linings. Although the standard uses a blister size scale of 0 to 10 this chart uses the most common sizes of blisters found in the field. The standard does not use a reference for the size of each of the blisters depicted. CSI used this scale as a means for further quantification by qualifying the largest blister depicted as being 1 inch in width (Blister Size No. 2) and the smallest blister being 1/32 of an inch in width (Blister Size No. 8).

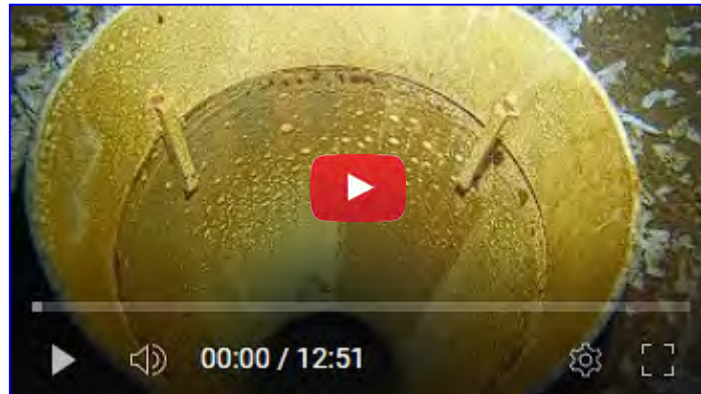
Click on link or cut and paste the external link: https://youtu.be/RJ1m4Hd2_Ac

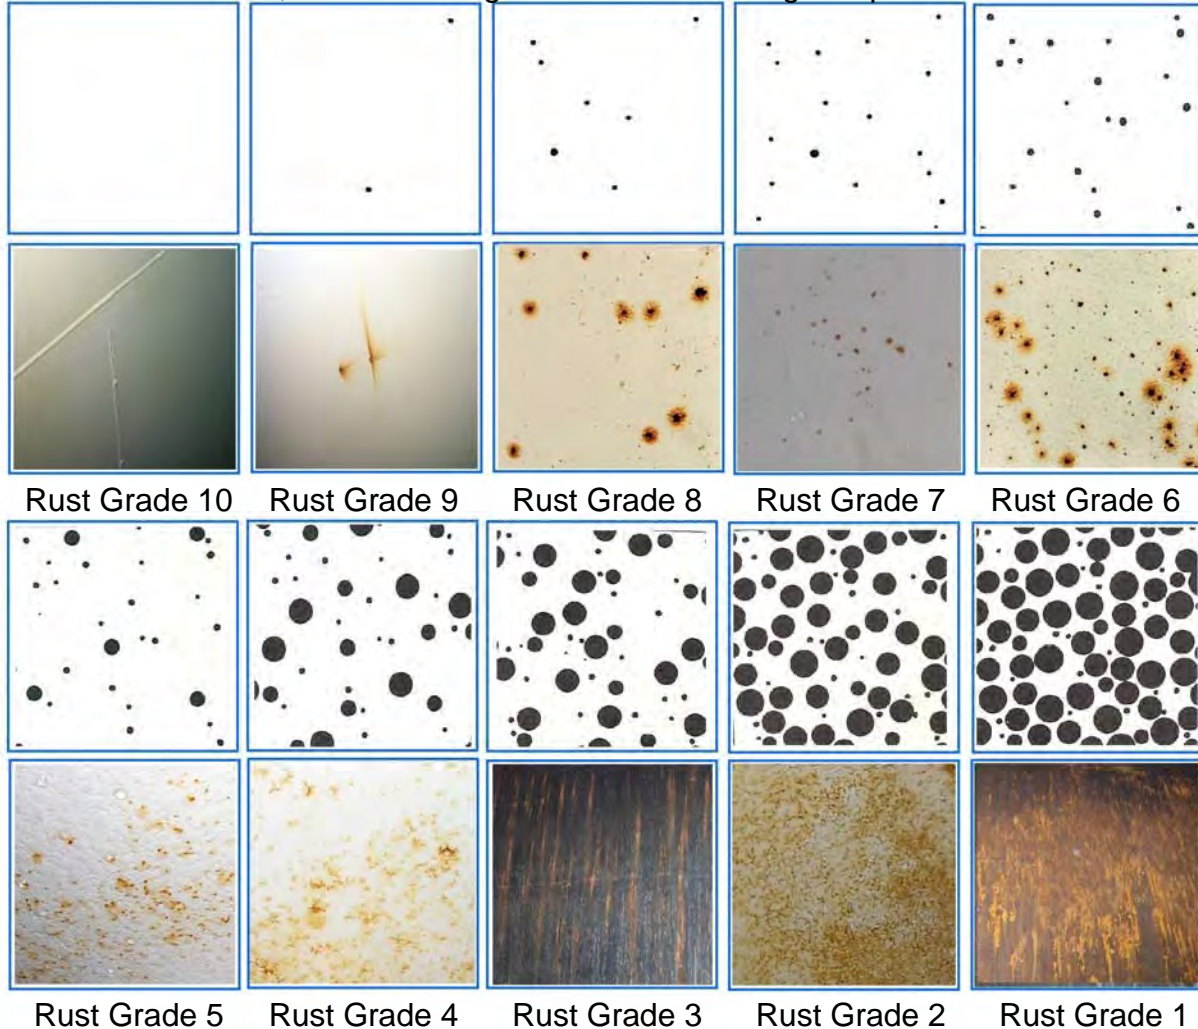
Chart 2 -Rust Grade The black and white figures below depict the standards referenced in ASTM D610 “Standard Test Method for Evaluating Degree of Rusting on Painted Surfaces.” Below each standard is a photographic depiction of each level of corrosion, as used by CSI Services, Inc. The standards depict the percentage of rust on a scale from 0 to 10, with 10 having no rust and 0 having complete rust.

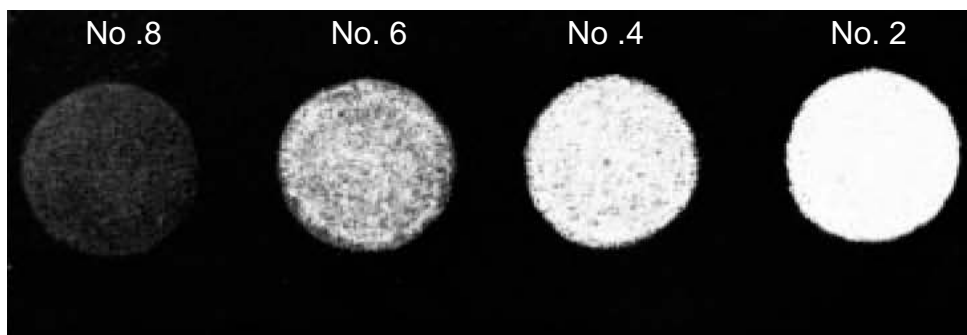
Light Colored Paints

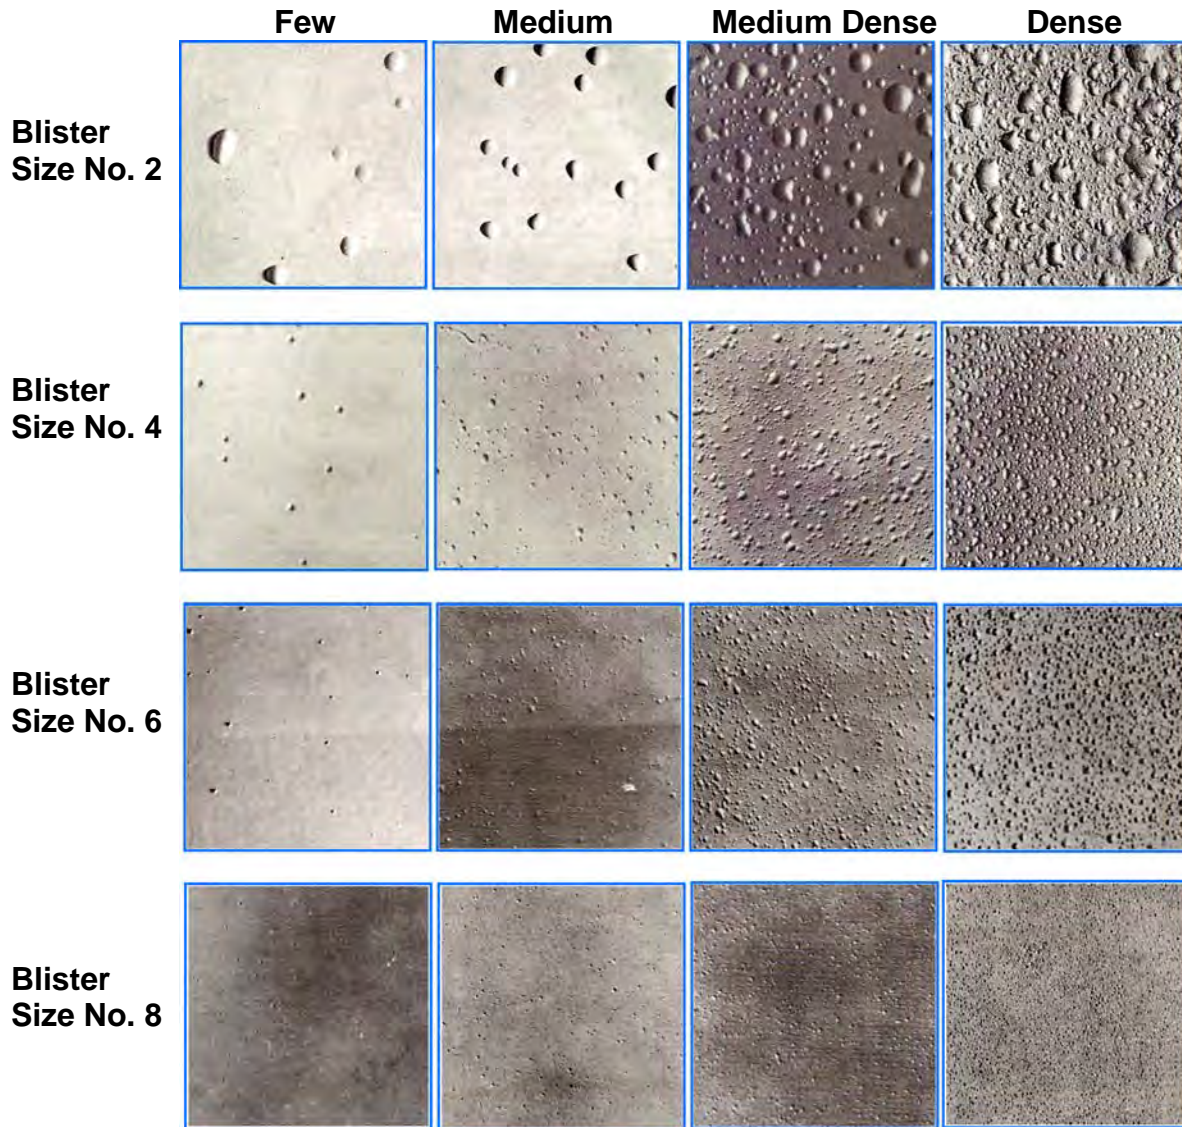
Chart 6 – Blistering Rating The figure below depicts the photographic standards referenced in ASTM D714 “Standard Test Method for Evaluating Degree of Blistering of Paints”. This test uses these pictorial standards to quantify both the size and density of blisters that may develop in linings. Although the standard uses a blister size scale of 0 to 10 this chart uses the most common sizes of blisters found in the field. The standard does not use a reference for the size of each of the blisters depicted. CSI used this scale as a means for further quantification by qualifying the largest blister depicted as being 1 inch in width (Blister Size No. 2) and the smallest blister being 1/32 of an inch in width (Blister Size No. 8).
